The Haiti Earthquake Mw = 7.0 of January 12th 2010: structural and geotechnical engineering field observations, near-field ground motion estimation and interpretation of the damage to buildings and infrastructure in the Port-au-Prince area

Panayotis Carydis*, Efthymis Lekkas**

SUMMARY – The Mw 7.0 destructive earthquake that struck the Republic of Haiti on January 12, 2010 was one of the deadliest of the last century in the region. What has been concluded after a field study during the period from 16th to 22nd of January 2010 is that this event is mostly a man-made natural disaster. This is due to the very adverse social, political and economic conditions that existed before the earthquake that greatly contributed to the lack of any building – construction code and control of land use and the lack of any governmental – public services during the post-earthquake emergency. The primary effects of the earthquake were worsened due to the inability or absence of any preparedness for search and rescue and help the victims. The frozen response of the structures to the seismic event, observed during the field trip, gave valuable information about the ground motion, since instrumental rec

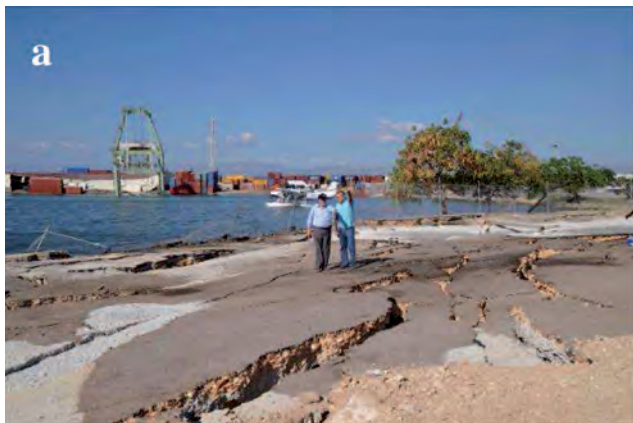
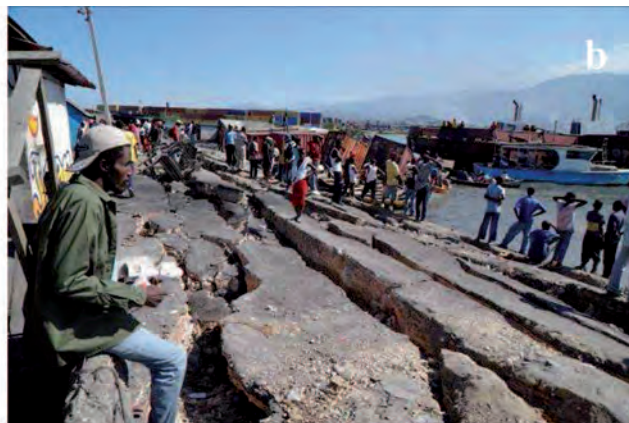
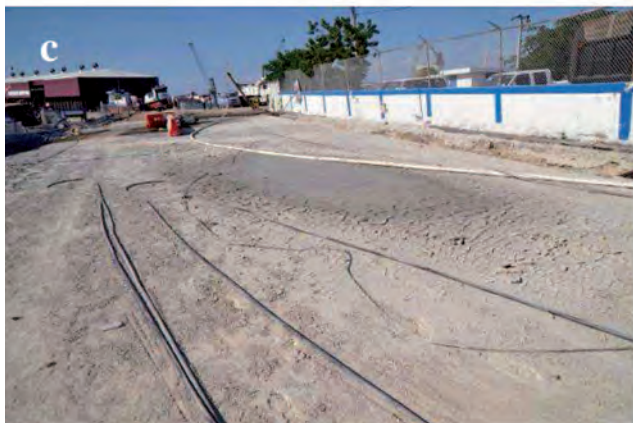
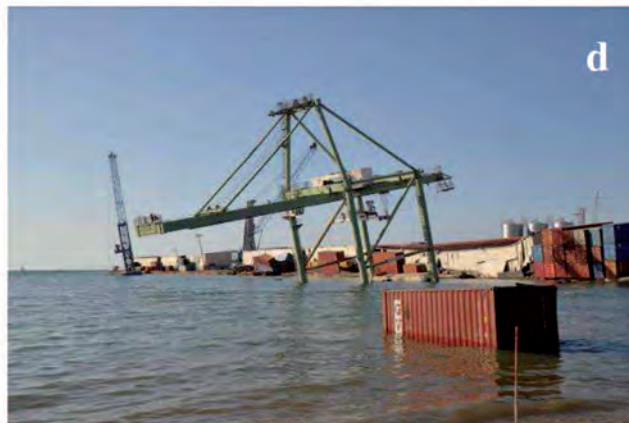
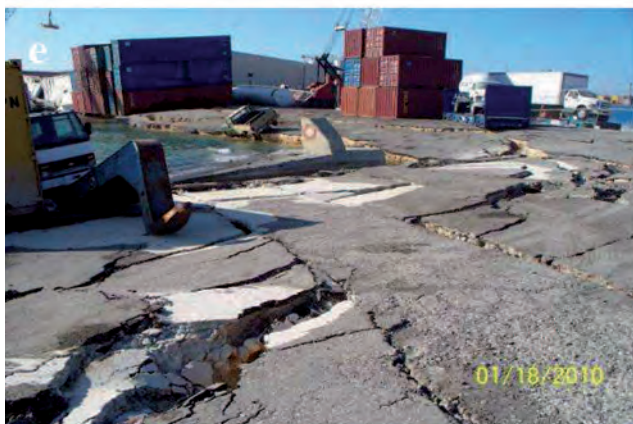
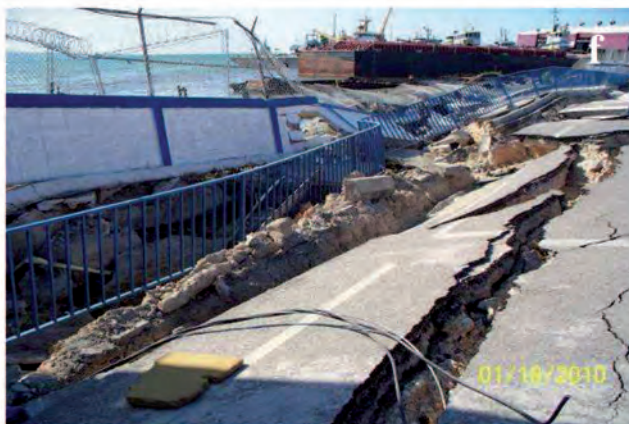
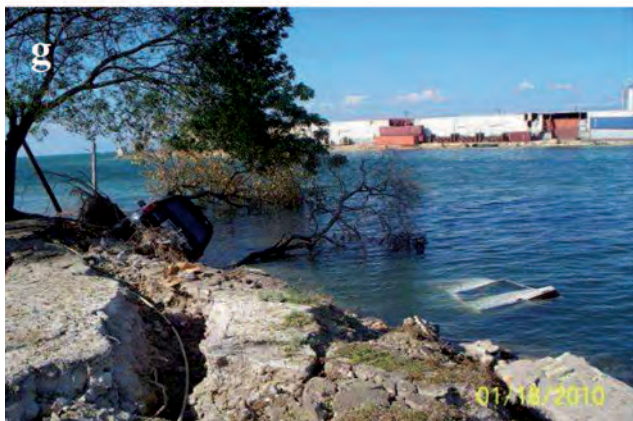
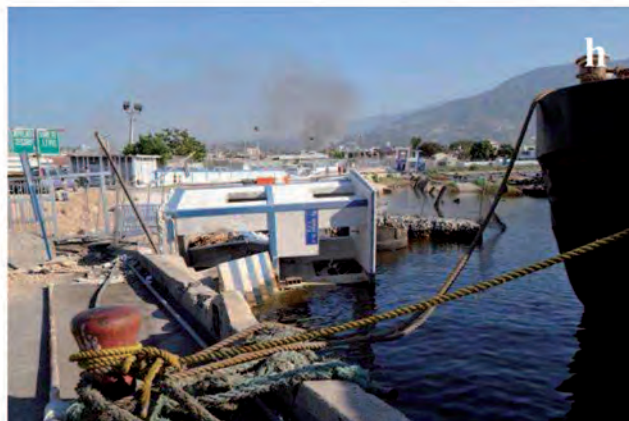
Fig. 3a-h. Extensive liquefactions and lateral spreading phenomena caused significant damages in the port facilities of Port-au-Prince. Marine transportations and shipping were interrupted during the initial period after the main shock.

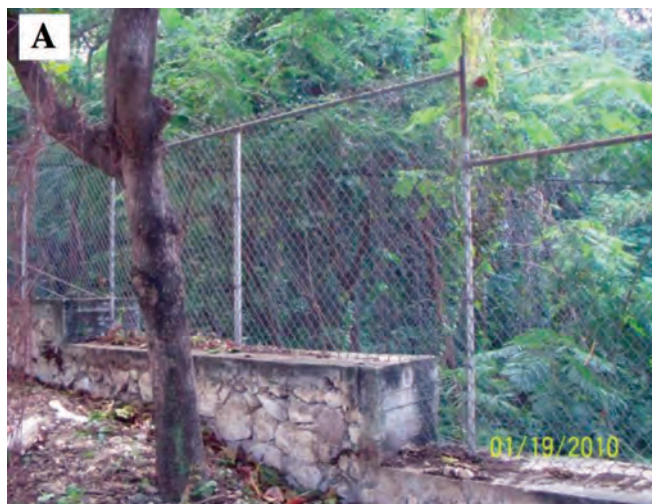
(a) General view. The plane of the fence is along NW-SE direction.

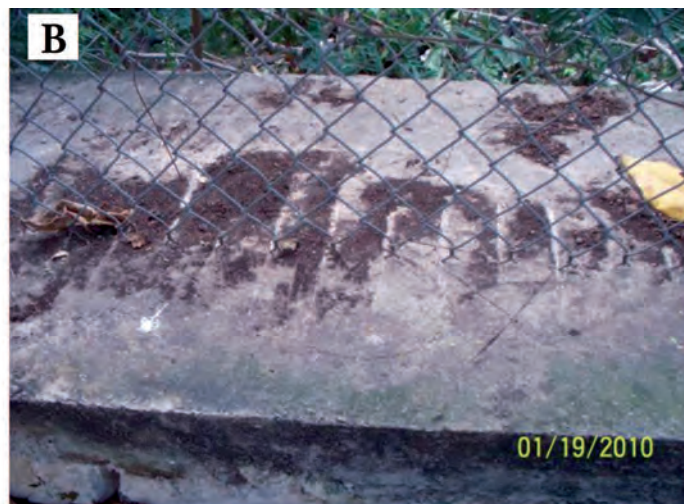
(b) Details A of the observed imprints – light scratches, by the lower wires on the steel net on the concrete base. The direction of the motion is NE-SW.

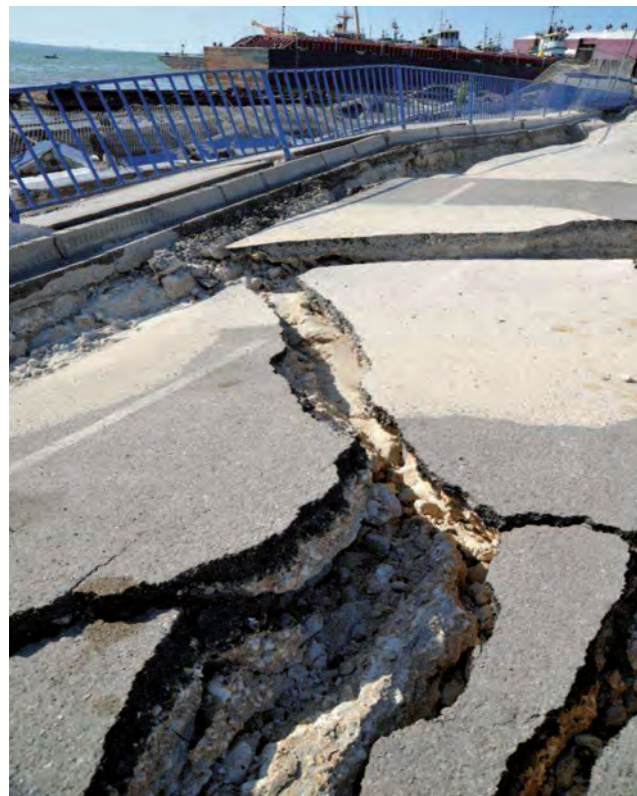
Fig. 5. Port-au-Prince port area. The ejected material could form a continuous surface if the broken pieces are assembled together like in a puzzle. This shows that sand and water ejections started before the actual liquefaction and the lateral spreading phenomenon took place.

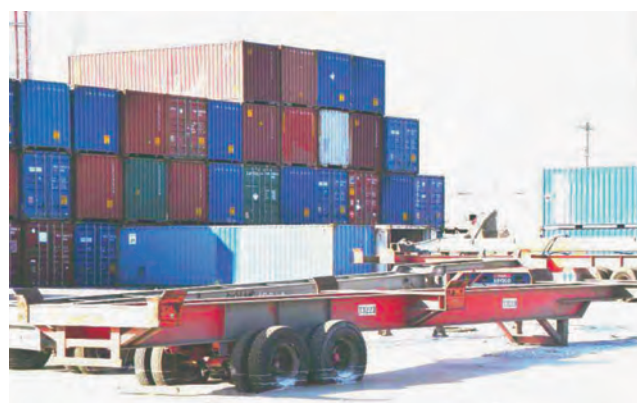
Fig. 6. Another documentation that the sand and water spouts in the port started before the strong ground shaking (please note the two parallel horizontal white signs on the tires which are due to bounding of the lorry platform on the ground during the strong phase of the ground motion. The ejected material was already there).

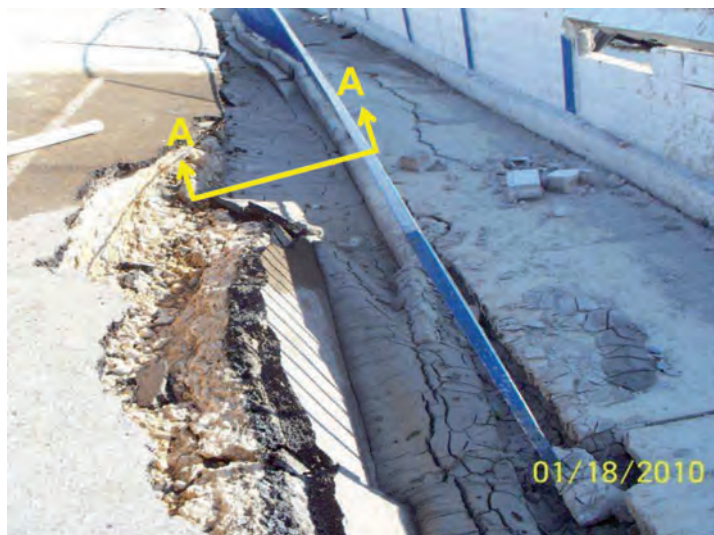
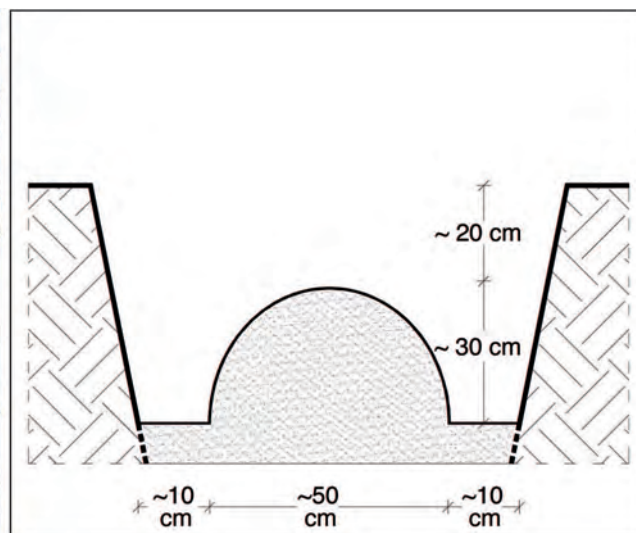
(a) General view of the trench with ridge of liquefied material inside it.

Fig. 7a, b. Ridges of liquefied material was observed inside the trenches. Their crest was almost in the center and parallel to the trenches axis. The visible thickness of the ridge was about 30 cm almost uniform all along its length. The internal visible sides of the trenches were found clean, justifying in this way the spouted material continued taking place during the third phase too.

During the third phase, the ejection of ground material continues taking place, but gradually decreases until its completion. Not any significant ground deformation primary connected to the actual liquefaction phenomenon takes place. This phase is documented, among others, in Fig. 7 where fine liquefied material continues to be ejected, well after the completion of the large ground deformations – main liquefaction phenomenon. According to this evidence, the ejected material – that possesses a high viscosity – formed inside the trenches symmetrical ridges along the central axis of the trench. This may mean that the material was still gushing up even after the integration of the destructive strong motion and the creation of the large ground displacements. If the liquefied material was inside the trench and after that, the trench became wider, the material should have come down having its concaves turned upwards. This is absolutely opposite to what it has been observed all over the many trenced created, Fig. 7.

This means that the ridge was created after the final formation of the trenches. Thus, it is more likely that the pore water overpressure that created the ridges inside the trenches was still active, perhaps under smaller pressure, even after the final integration and complete ceasing of the dynamic ground motion. This is evidenced by the slopes at the ridges that are still standing intact, Fig. 7b. These ridges should have become at least flat under the action of any dynamic vibration such as the seismic ground motion. The high water content of the liquefied material, decreasing its high viscosity, contributes also to the above mentioned argument. A logical scenario for the explanation of this phase, from the engineering point of view, is that

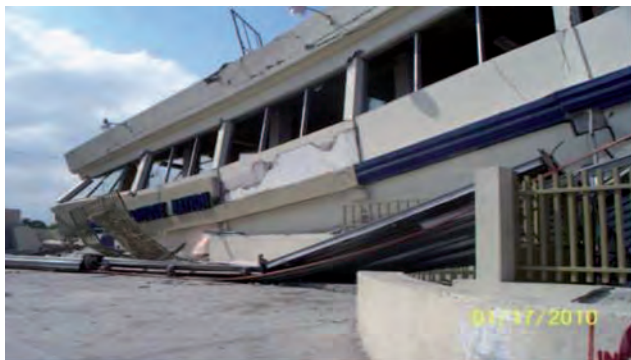
(a) Typical collapse of a contemporary building with reinforced concrete framework.

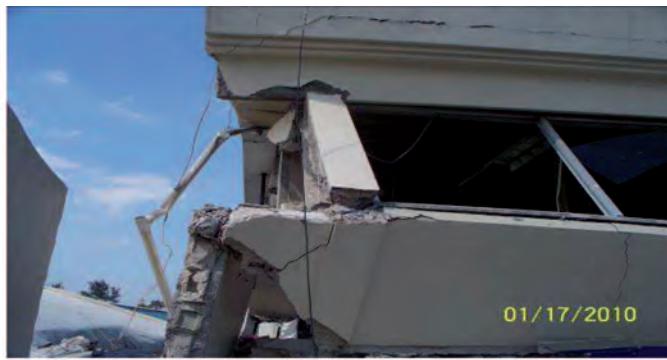
(b) A detail of (a), notice the inadequate reinforcement

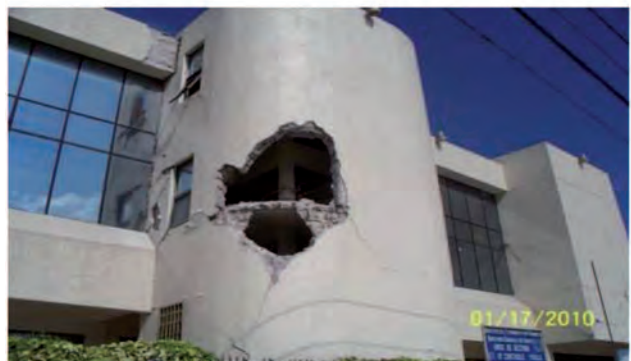
(c) Jet components from different places around the building. Glazing is intact!

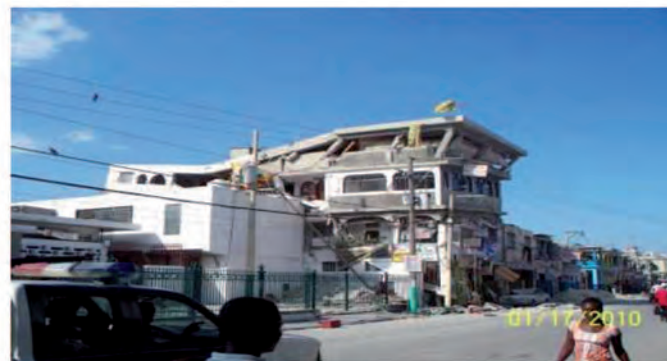
(d) Typical collapse of a multi-storied buildings with reinforced concrete framework.

Many multistoried buildings suffered extensive damage or collapsed. The type of collapse is of the pancake-type, where the upper floors fall over the lower ones without any horizontal translation. This is attributed to the strong vertical component at the very first phase of the seismic motion, due to the emerging waves (P). The buildings that were not damaged in the first phase of the earthquake were destroyed by the second one, as this can be justified from their horizontal displacements. The second phase is dominated by the horizontal seismic motion (S), which is more harmonic with longer predominant periods, larger displacements and longer duration.

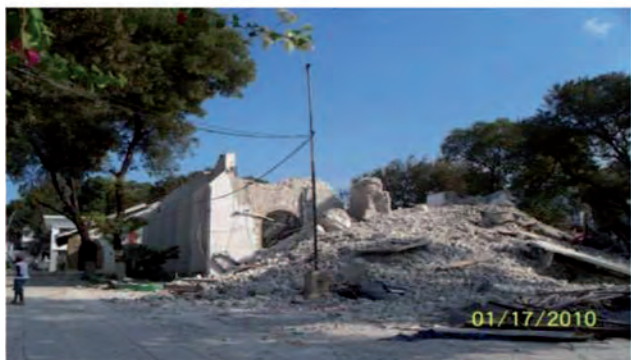
(e) The arch-like lintels over the windows survived.

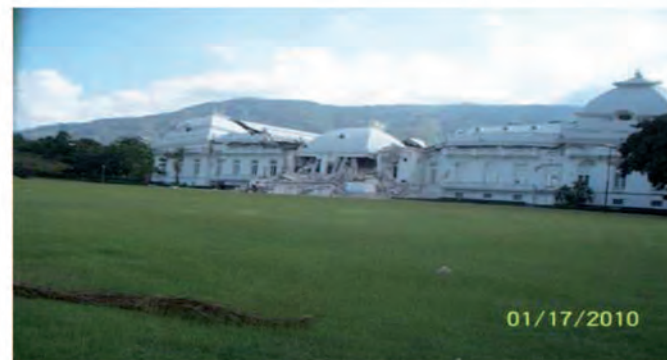
(f) The Presidential Palace. An almost symmetrical vertical collapse of the upper level.

The majority of these monumental buildings suffered from heavy damages to partial or total collapse. The collapse in the majority of the cases occurred within the perimeter of the buildings, Fig. 8f, while the most of the other walls remained standing in their position vertically. In accordance to this fact is the observation of unbroken glasses of the windows, even in cases that the building had suffered extensive structural damages. Furthermore, the arched lintels remained in their position, in spite of the fact that in many cases the rest of the building collapsed, Fig. 8e. This type of collapse could be attributed only to a strong vertical component of the ground motion which exceeds 1.0 g. The starting moment of the collapse should have been from 4 sec up to 7 sec, when the horizontal component of the emerging waves had not arrived yet. This was based on the fact that not any sign of significant horizontal motion had been noticed. The vertical collapse occurred abruptly, allowing no chance of reaction for escape or protection to the building occupants.

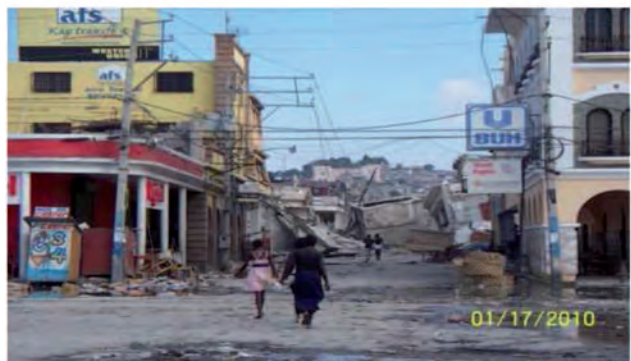
(g) Typical street view after the earthquake.

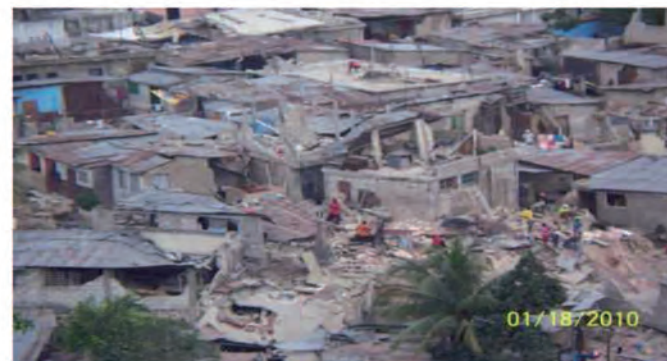
(h) Informal housing destroyed on sloping ground,

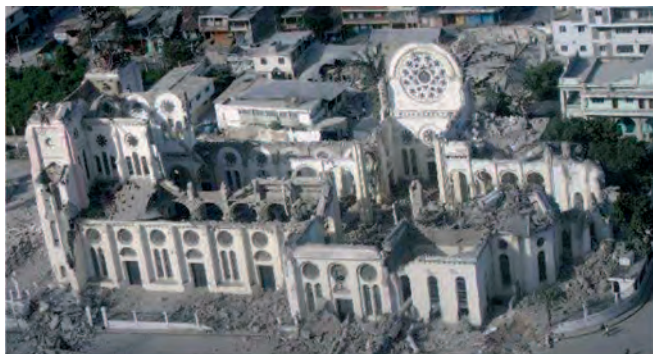
(a) Aerial view from S-E. The roof collapsed within the ground plan of the Port-au-Prince Cathedral.

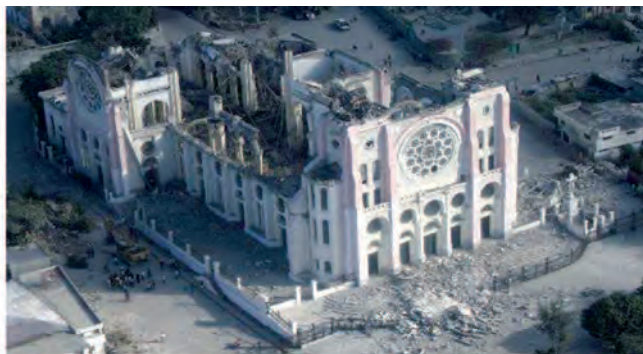
(b) Aerial view from N-W side. All main walls of the Cathedral remain intact, vertically.

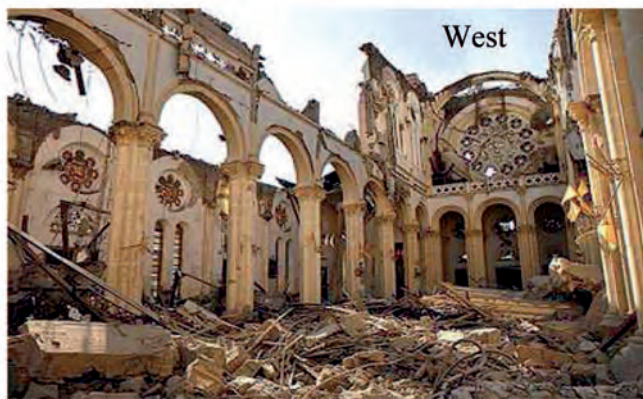
(f) Internal view of the Cathedral of Port-au-Prince. The roof collapsed within the plan of the church.

Fig. 9. A study case of the damaged Cathedral Notre-Dame of Port-au-Prince. Comparison with other similar cases, in which the roof or dome collapsed inside the ground plan of the church while the walls and bell towers remained in their position.

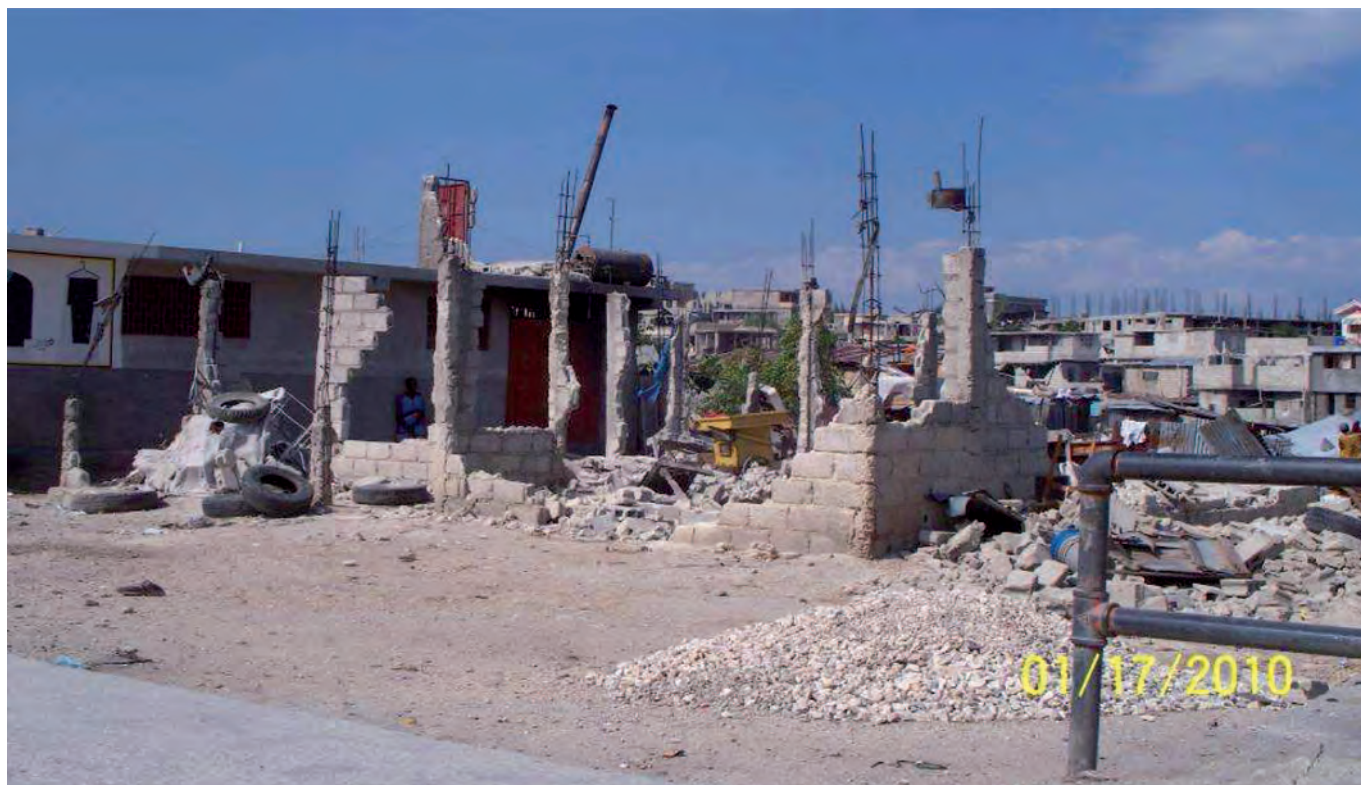
Fig. 10. Typical view of the way of self constructing of low income masonry buildings.

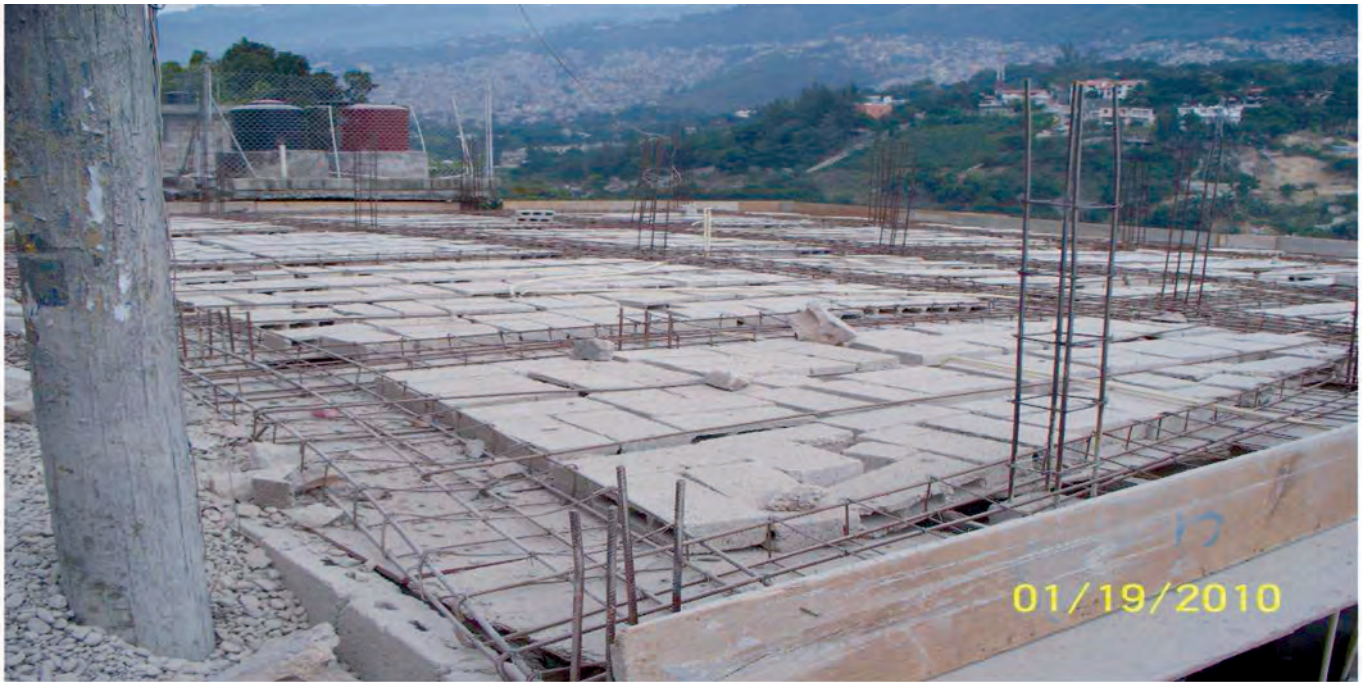
(a) Flat slab construction of the third floor. Inadequate reinforcement of small diameters and at large distances. Small dimensions of columns. Absence of any shear wall.

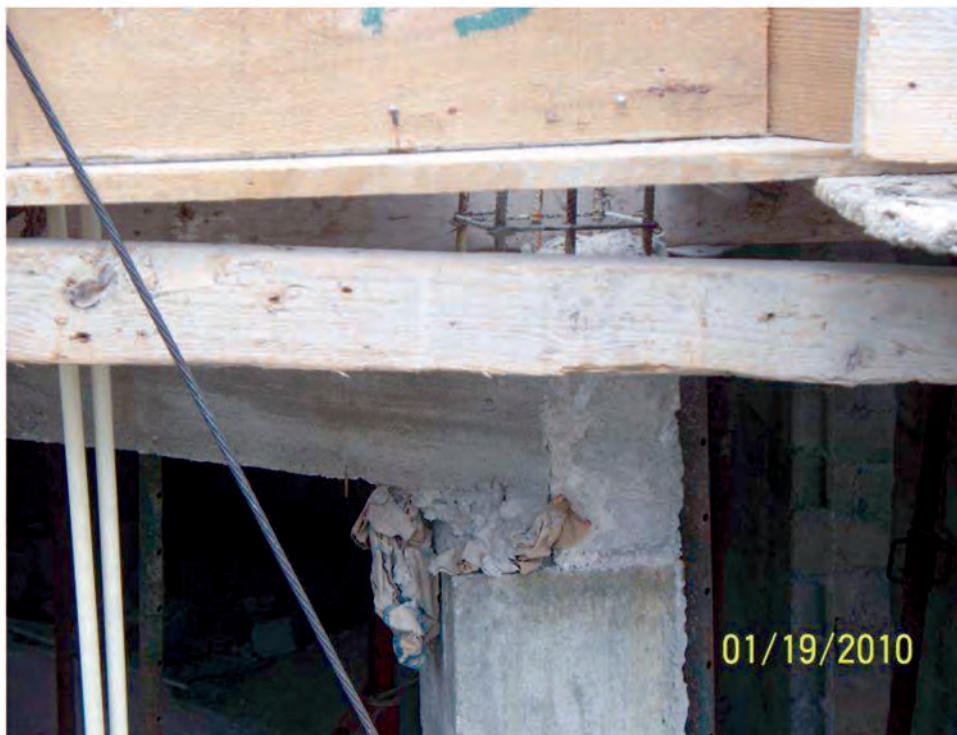
(b) A detail of a column to beam joint of the framing system shown in (a).

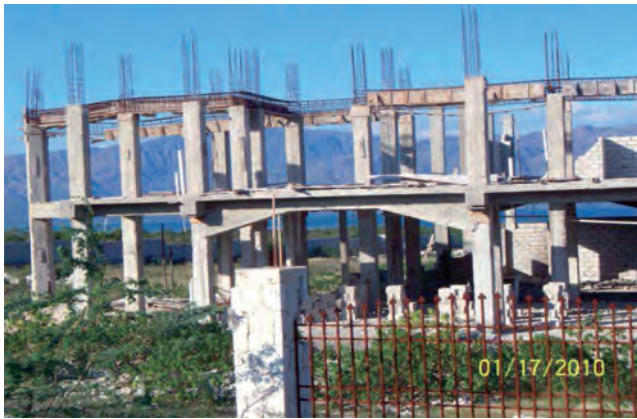
Fig. 12. A reinforced concrete framing system was ready for concreting before the earthquake as found after it. Total lack of any stiffening element. Note the beam at the center of ground floor with the triangle strut was added after the concreting of the floor.
