The October 23 ($M_w = 7.2$) and November 9 ($M_w = 5.7$), 2011 Van, Turkey earthquakes. A geoscientific and engineering report

Panayotis Carydis*, Efthymis Lekkas**, Christos Papaioannou***, Andreas Tsokos****, John Delakouridis*****

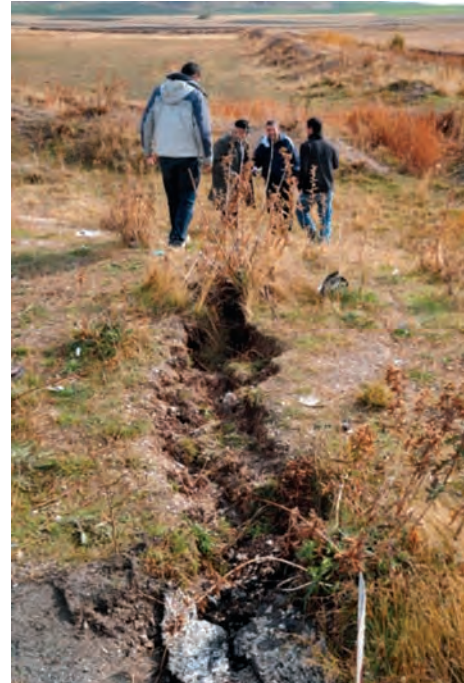
Fig. 2. The seismic rupture, crossing the main road of Van-Ercis, is very close to epicenter, which is associated with the October 23rd, 2011 earthquake, see Fig. 5.

cessive lakes and ground elevations, as a result of the pop-up and pop-down structures Fig. 2.

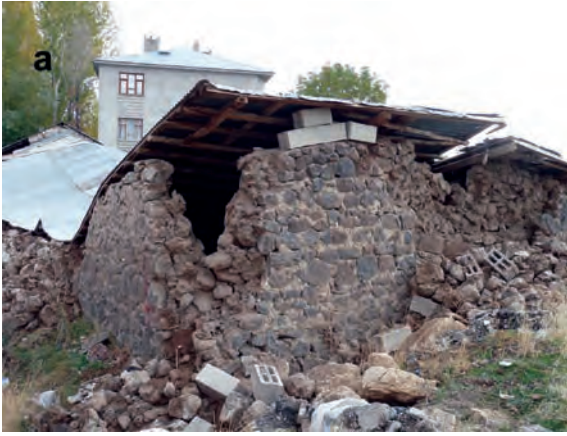
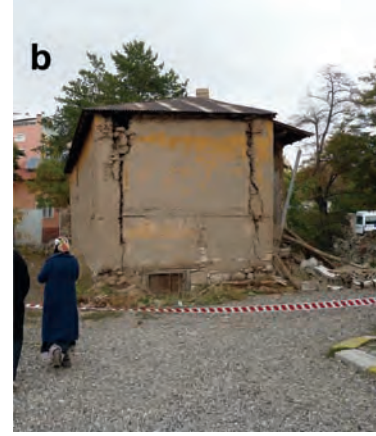
Fig. 16a, b. This manner of damage of simple houses indicates the dominance of vertical seismic component.

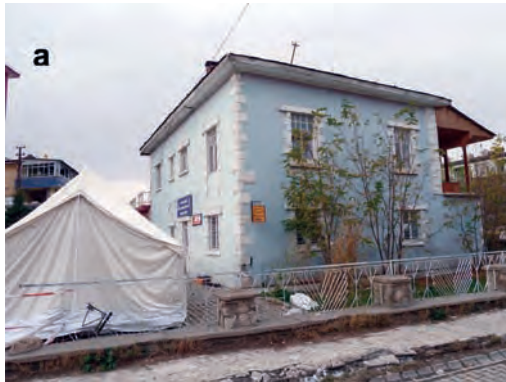
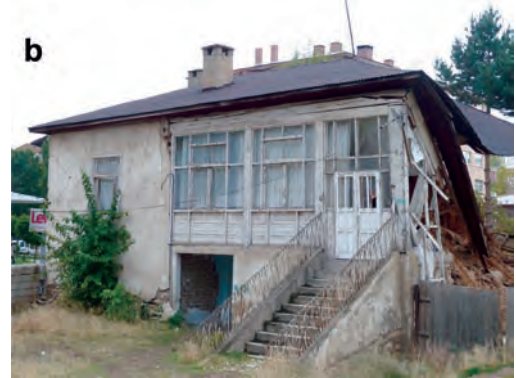
Fig. 17a, b. Traditional masonry buildings survived the main shock with minor or no damage.

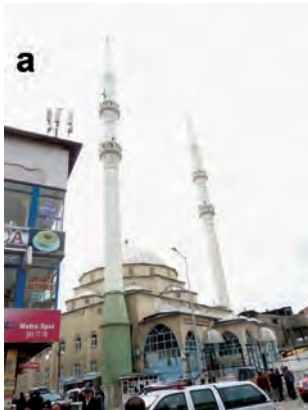
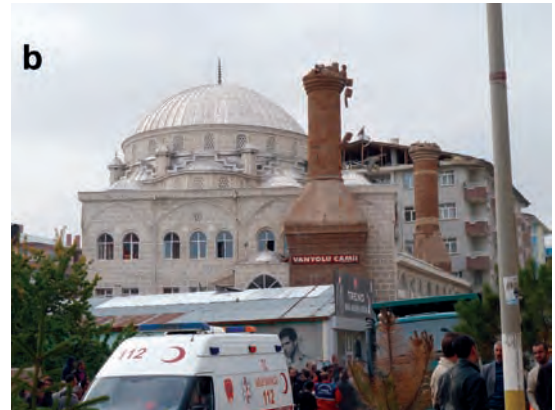
Structures of special construction type belong in the fourth category, as for example are the mosques which are mainly composed out of domes and minarets. Both structures present high earthquake resistance against an intense vertical seismic component. And this might be attributed to their symmetrical geometry around the vertical axis. In general, those structures did not suffer any noticeable damage except for a few cases of minaret toppling. The direction of toppling was towards the macroseismic epicenter of the first event.

Fig. 18a, b. Most of the mosques with their minarets weathered the main shock without any damage. In a limited number of cases parts of minarets toppled.

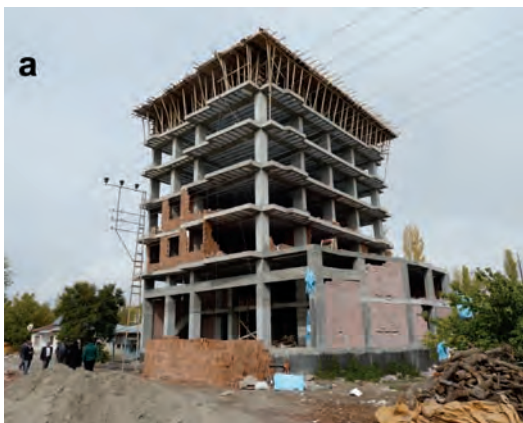
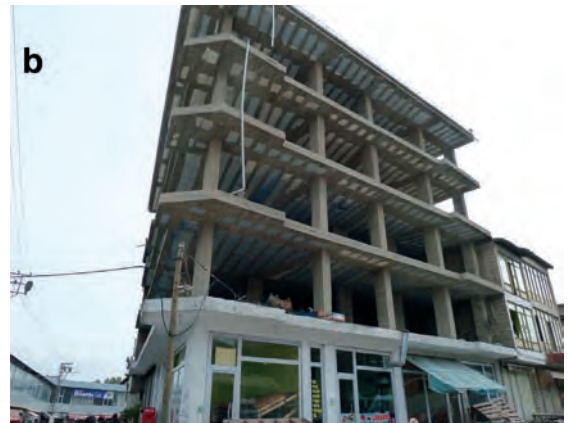
Fig. 19a, b. Flexible buildings with rather large openings and without shear walls, as well as those with a one way flat-slab construction system are prevalent in new structures.

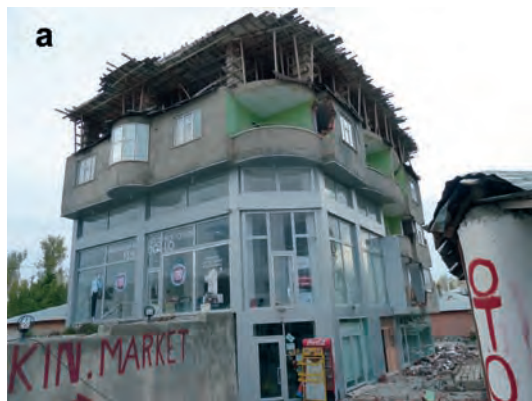
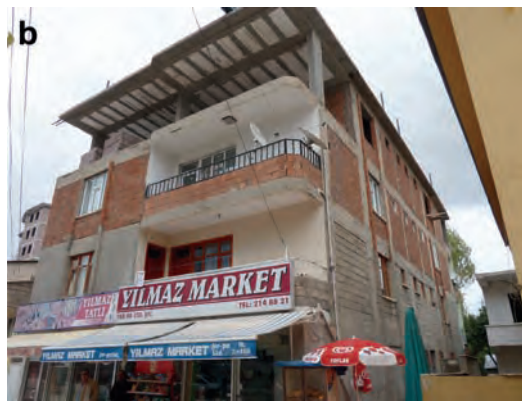
Fig. 20a, b. Usually, one or two storeys are added at the top and the balconies are externally closed with masonry partitions.

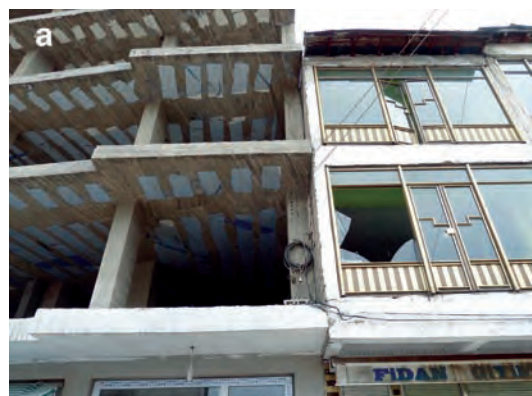
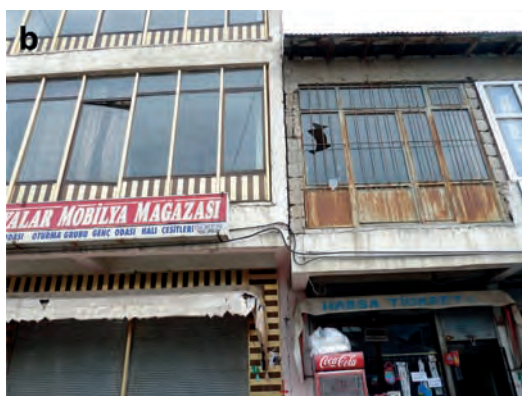
Fig. 21a, b. No evident horizontal motion, or breaking of glass panels, or pounding between adjacent buildings was observed.

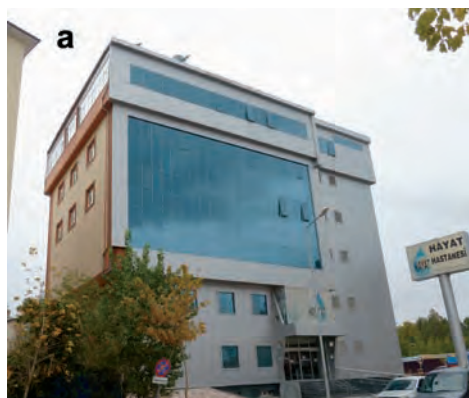
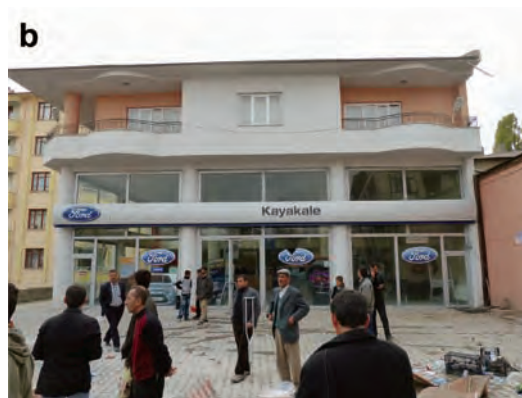
Fig. 22a, b. Externally, some well designed and constructed strong modern buildings, did not present any damage. Internally, the secondary elements and the content suffered extensive damage.

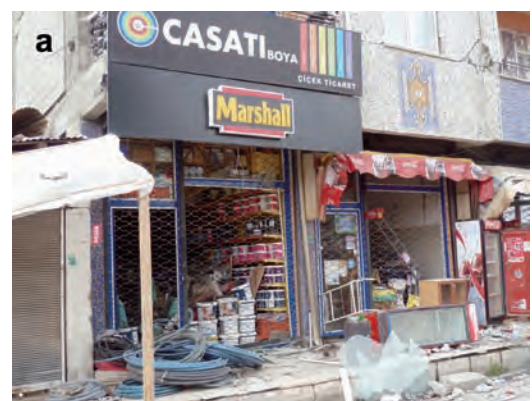
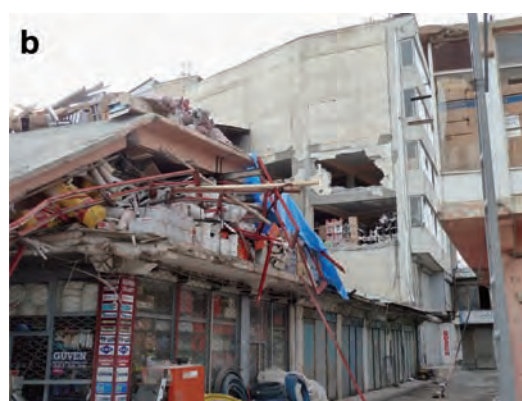
Fig. 23a, b. The content and appendages in old / flexible / soft buildings weathered the events with rather limited losses.

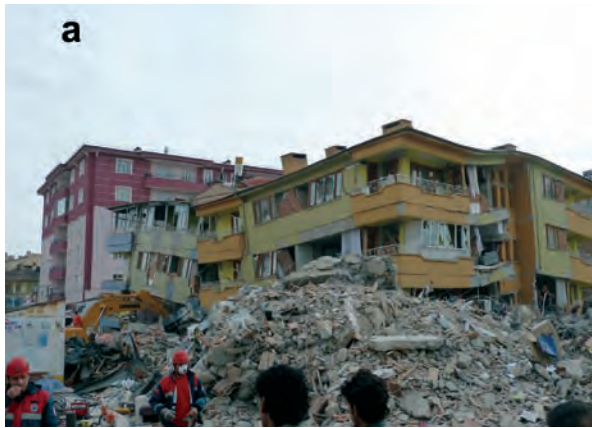
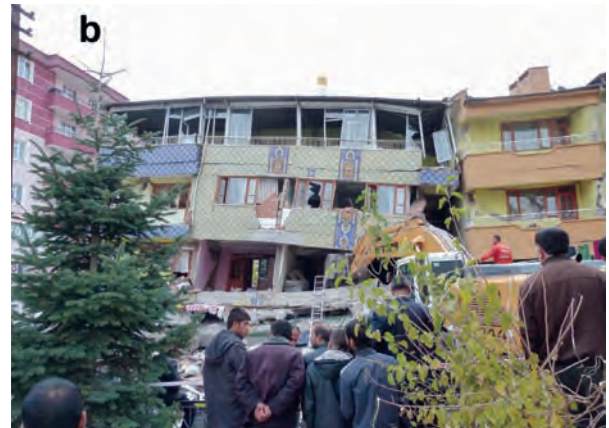
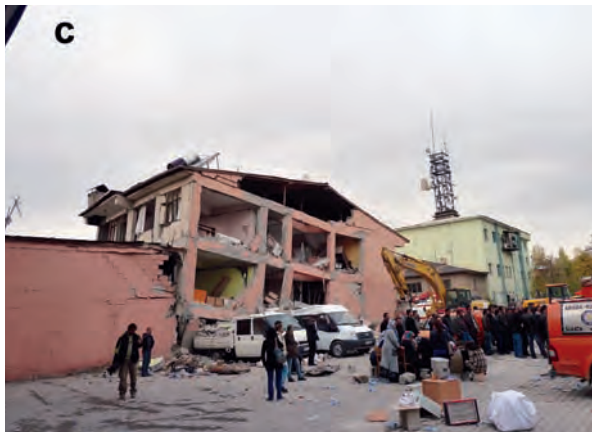
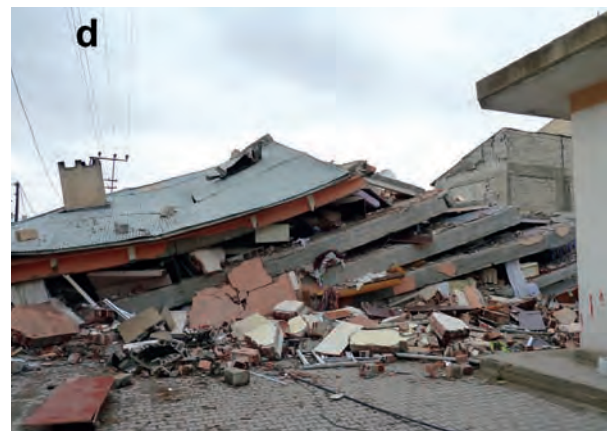
Fig. 24a-d. An agglomerate of collapsed buildings in the city center of Ercis. Note, that some chimneys are standing upwards.

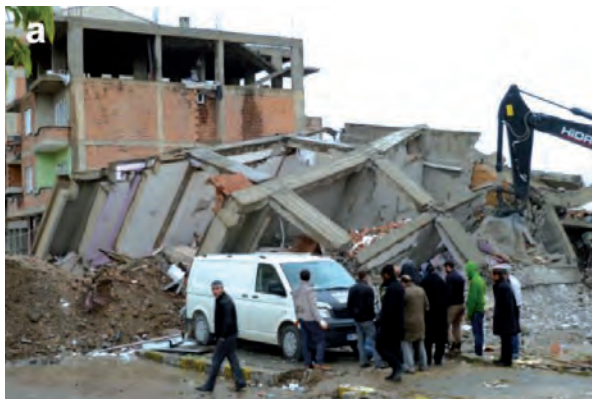
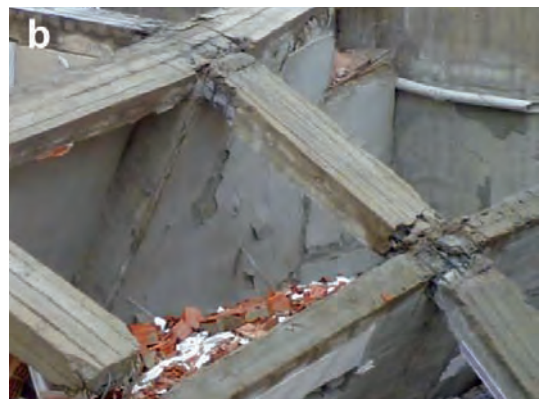
Fig. 25a, b. A technically interesting collapse. The reinforcement detailing is acceptable. Perhaps the concrete quality might have a problem or the concreting.

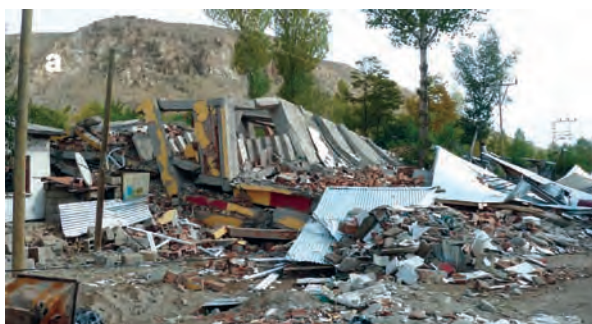
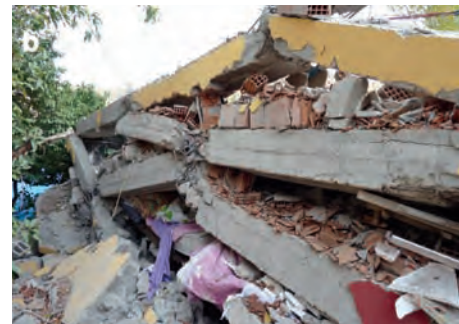
Fig. 26a, b. An other technically interesting collapse: a) In the fore-ground is the roof and the roofing corrugated iron-sheet; b) The top is the back column. The other columns are shaken off. Note that a flat-slab construction system does not allow any space for protection during collapse. The owner was describing that during the main shock he was staying on the ground. He felt two extremely violent upwards jolts, the one followed by the second making him to jump-up. At that time the building was jumping-up too. It was balancing, at the first cycle it stood on the front columns in parallel to the street. Next, the building stood on the back columns and then in the front ones with a stronger stroke when it toppled over.

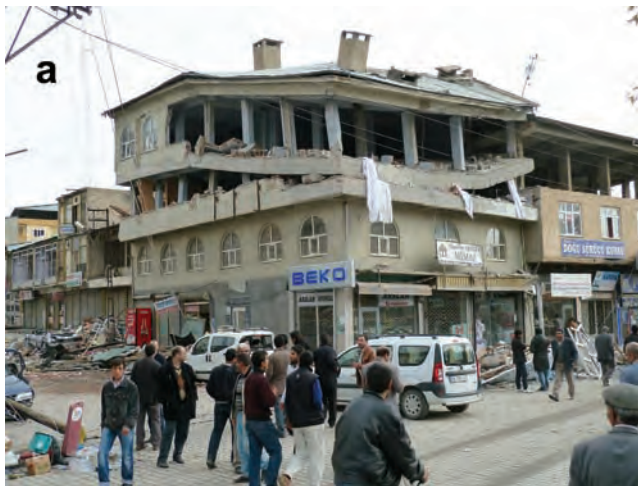
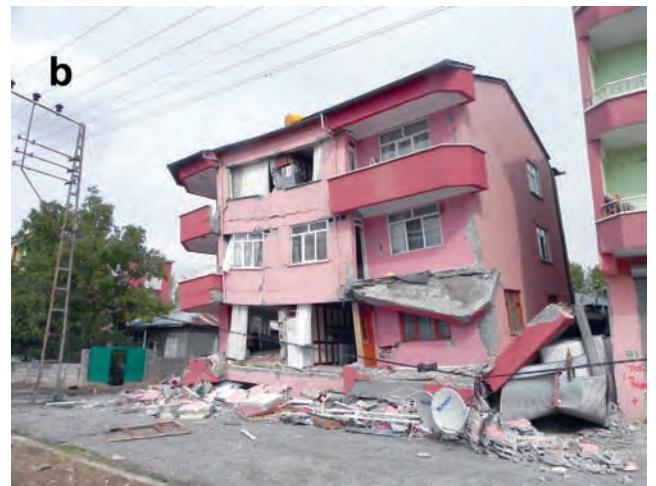
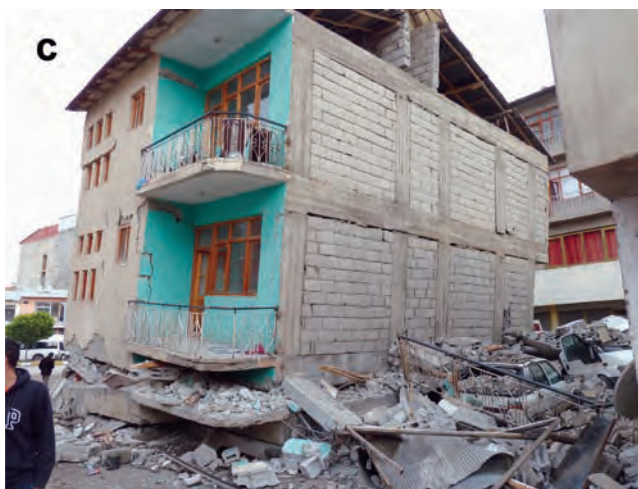
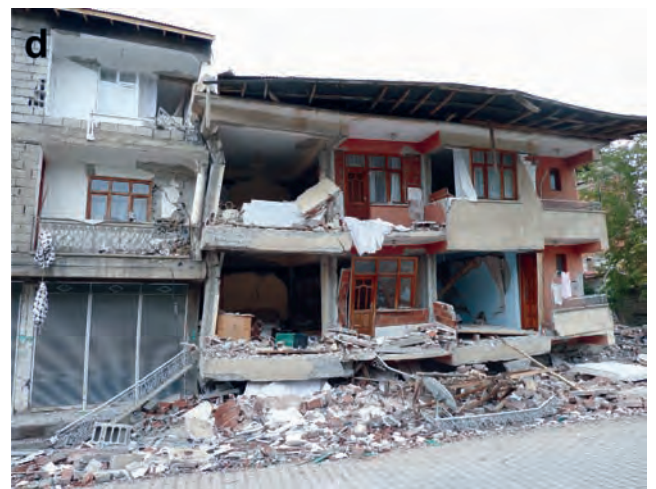
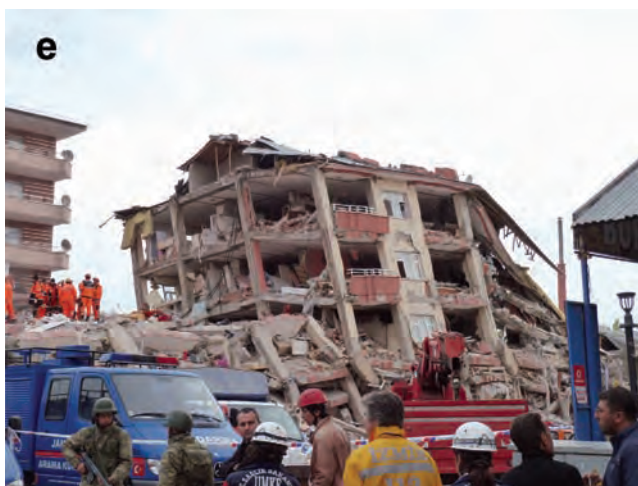
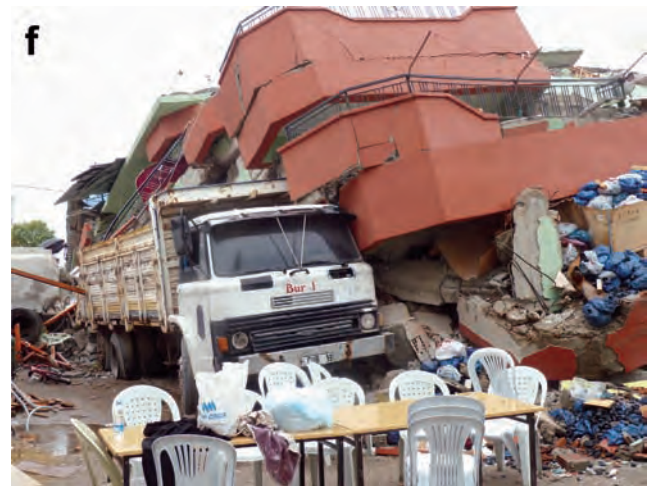
Fig. 27a-f. Heavily damaged and collapsed buildings in Ercis city.

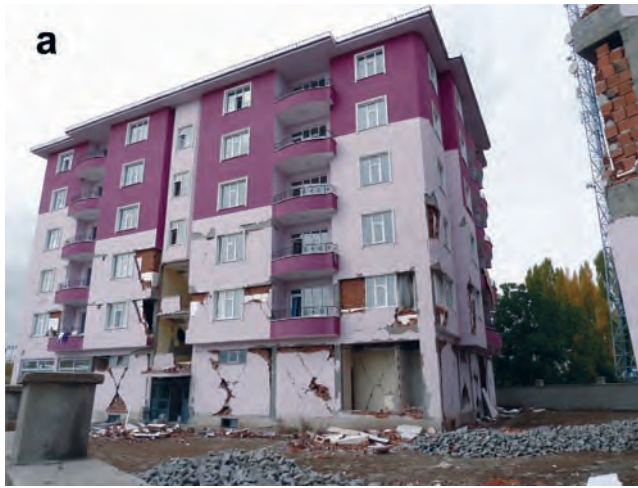
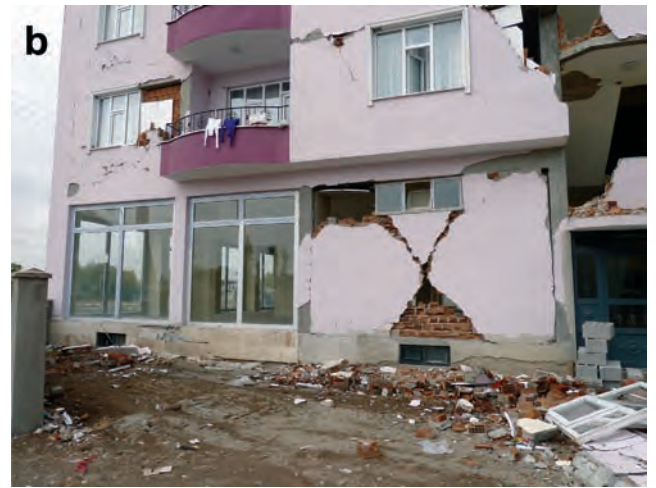
Fig. 28a, b. Note that the glass panels are intact while the walls are damaged especially at the lower levels. This is the case for almost the majority of the damaged-not collapsed multi-storeyed buildings, in Ercis city.

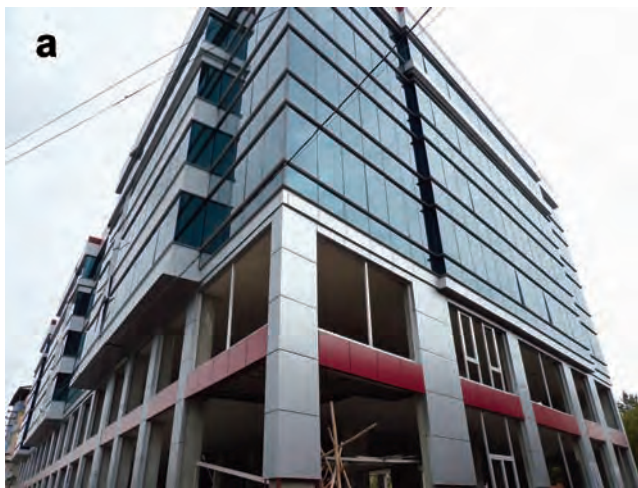
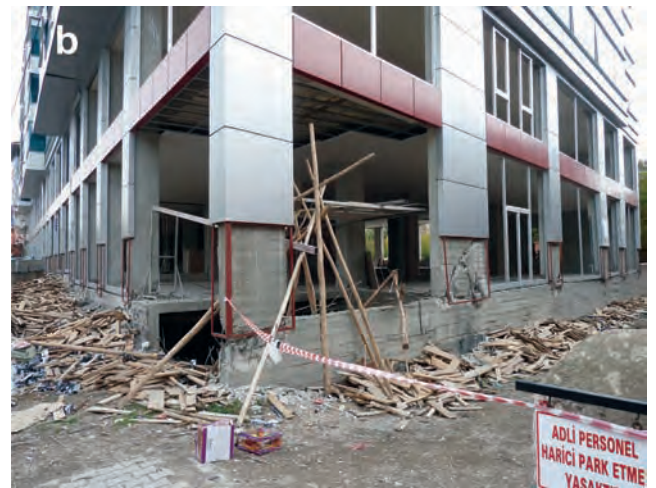
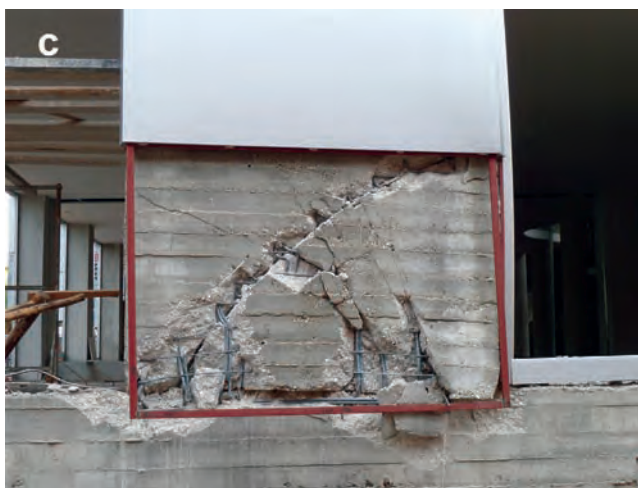
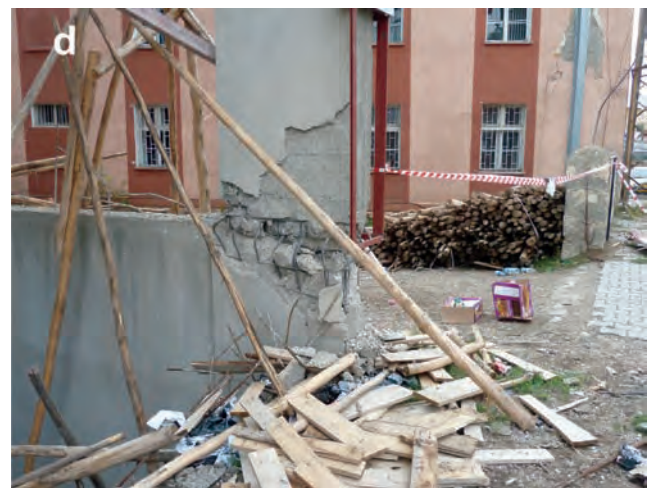
Fig. 29a-d. A just erected building with acceptable reinforcement detailing. The majority of the columns in the ground floor suffered mainly compression damages. There are no noticeable horizontal displacements.

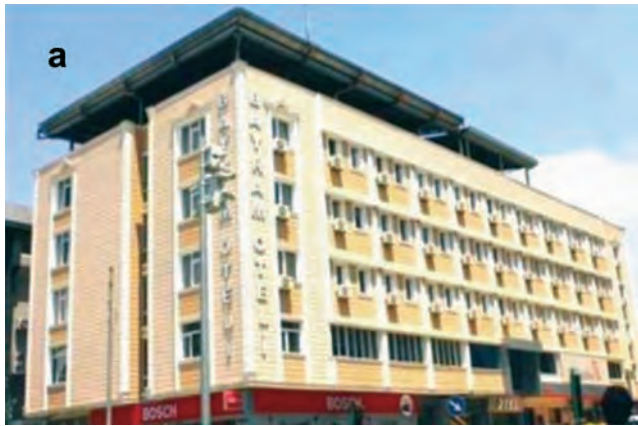
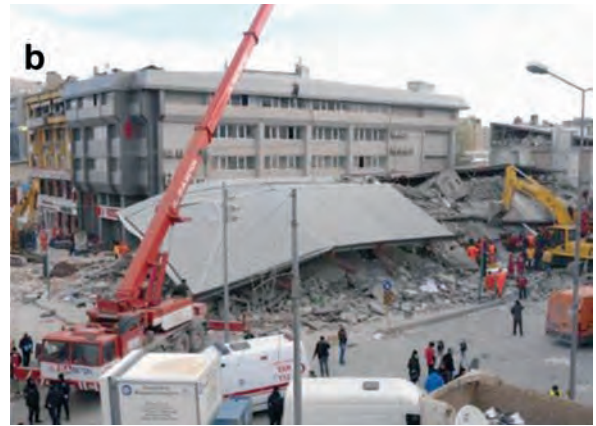
Fig. 30. a) The free standing Bayram Hotel before the earthquake and after the addition of a floor with a light weight roof. b) The collapsed roof is covering the plan, of the collapsed building in a parallel way to the pavements.
