# The Emilia Romagna, May 2012 earthquake sequence. The influence of the vertical earthquake component and related geoscientific and engineering aspects

Panayotis Carydis\*, Carlo Castiglioni\*\*, Efthymis Lekkas\*\*\*, Irene Kostaki\*\*\*\*, Nikolaos Lebesis\*\*\*\*\*,  
Alberto Drei\*\*\*\*\*

**Keywords:** Earthquake reconnaissance; Apennines-Po Plain seismotectonics; strong motion records; vertical seismic component; cultural heritage damage; prefabricated industrial buildings; rack steel structures.

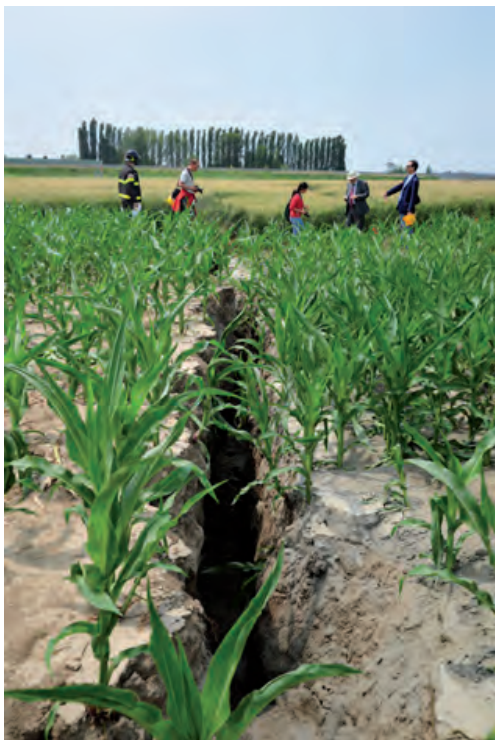
Fig. 11. ENE-WSW trending lateral spreading and liquefaction in San Carlo. Estimated ground crack length 300m. Maximum opening of 1m and vertical offset of 0.5m.

Ground cracks with great amounts of ejected liquified sand on the field and water fountains as high as 1.5m were observed by local residents at the time of the 20th May 2012 earthquake event, and suggests that the material was ejected with high pressure, higher than usually observed at events of this magnitude and depth. This concludes that the liquified zone is located at a lower depth than usual, around 10m as suggested by local geology (Figs. 11-15).

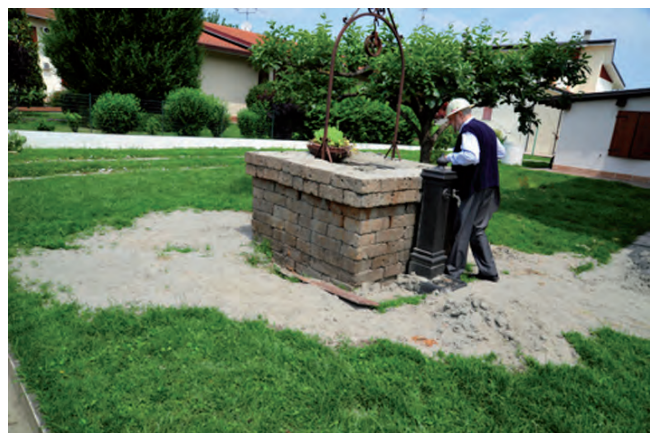
Fig. 12. Well with liquefied sand deposition due to violent ejection in San Carlo.

Due to the same liquefaction and pressure augmentation mechanism, liquified material ejected violently from wells, as seen in Fig. 12. Due to the greater depth of liquifiable formations, no great damage was observed on the area, in contradiction with Adapazari liquefactions (Izmit 1999-Turkey) and Christchurch liquefactions (New Zealand – 2011). This great differentiation in damage pattern and degree is observed due to a) the amount

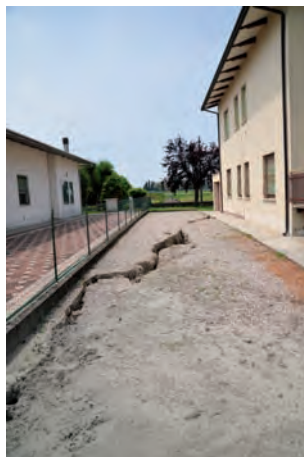
Fig. 13. *Lateral spreading in San Carlo, with ejected liquefied grey fine sand material in residential area. Ground cracks with opening of about 20cm, vertical offset of 10-20cm and local extensional strains is evident.*

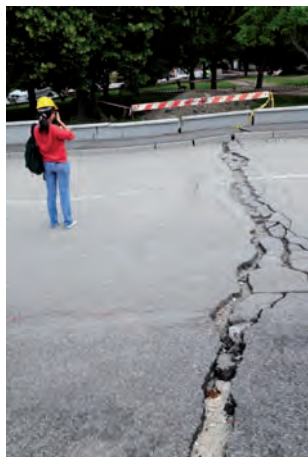
Fig. 14. *Lateral spreading cutting through roads and residential area, in San Carlo.*

As it is shown in Fig. 14, fences, pavements and other light weight structures, that apparently were founded superficially, have been heavily damaged, deformed and dislodged. On the other hand, build-

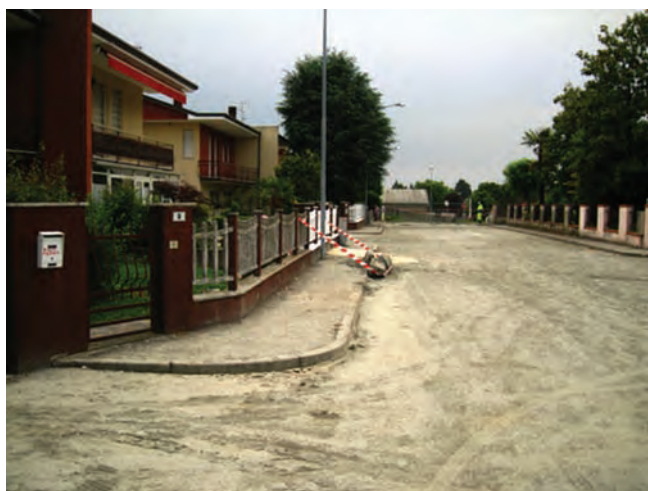
Fig. 15. *San Carlo residential area. Big amounts of liquefied material have covered roads throughout the city.*

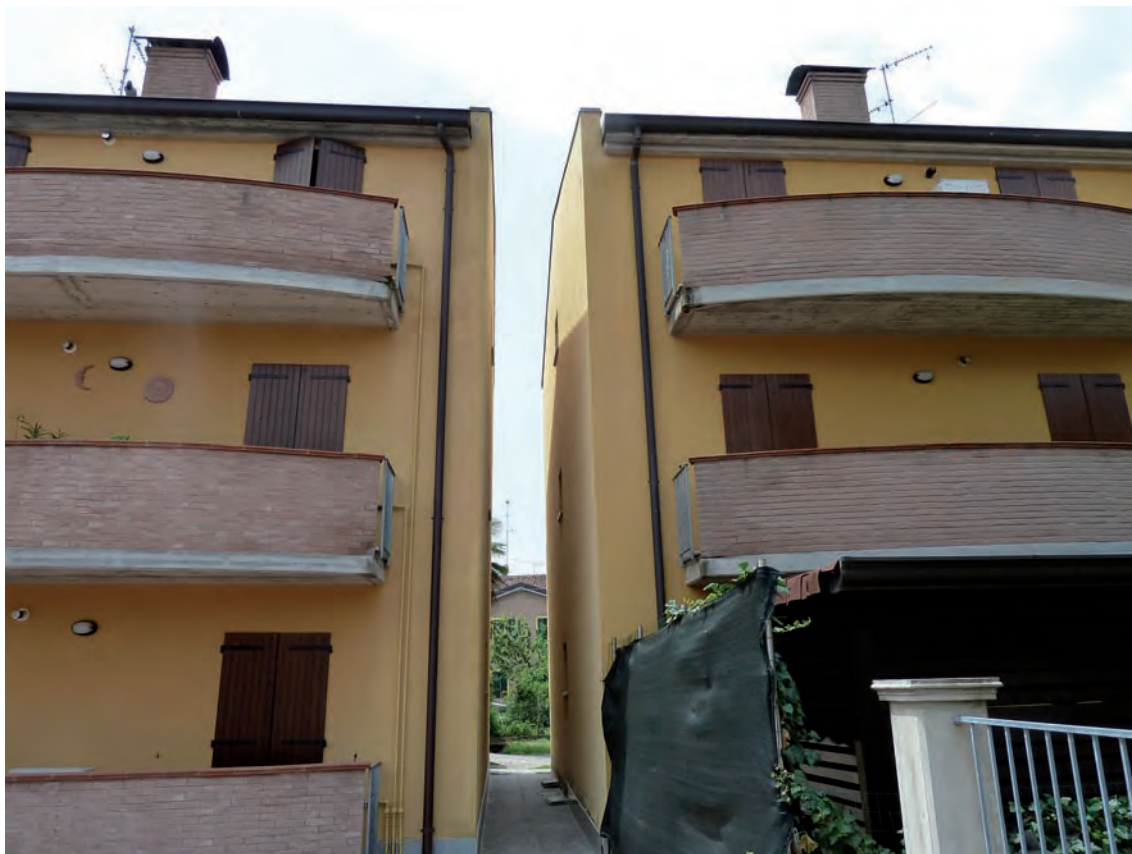
Fig. 16. *Rigid body motion of two neighbouring buildings that tilted one against the other. The buildings did not show other apparent damage.*  
Moto rigido di due edifici confinanti, che si sono inclinati uno verso l'altro. Gli edifici non mostrano segni apparenti di danni.

The only reported damage is a geometric deformation of two neighbouring buildings that were found to have tilted one against the other, as rigid bodies and without other apparent damage as shown in Fig. 16. So it is proved that the liquified material in deeper formations actually functioned as a kind of base isolation absorbing seismic energy, as already mentioned.

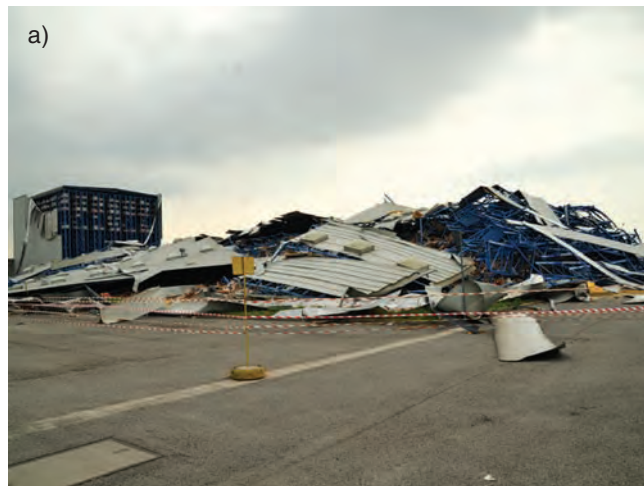
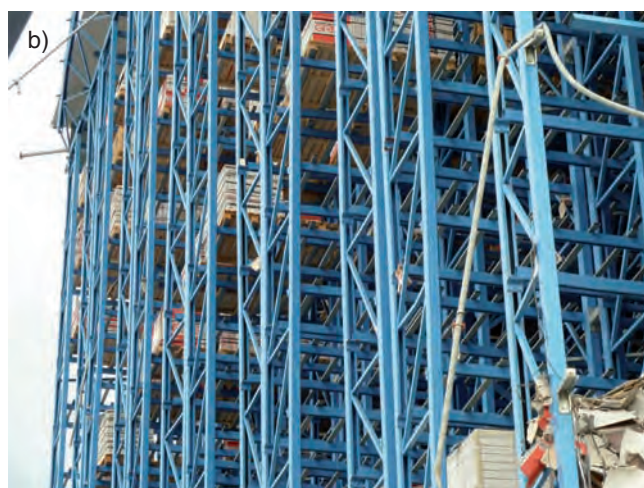
Fig. 18. a) A part of the ceramic warehouse in Sant'Agostino totally collapsed; b) This part of the same warehouse did not move. This can be very well justified by the relative position of the stored material to the steel members of the racks, which is in all positions the same. It must be taken under consideration that the positioning of the stored materials is computerized.

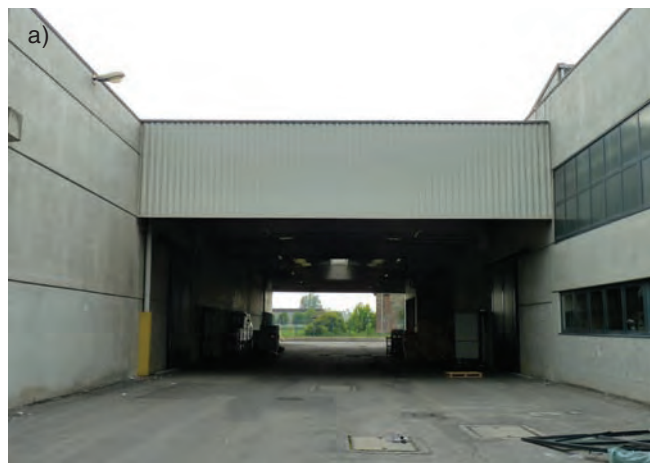
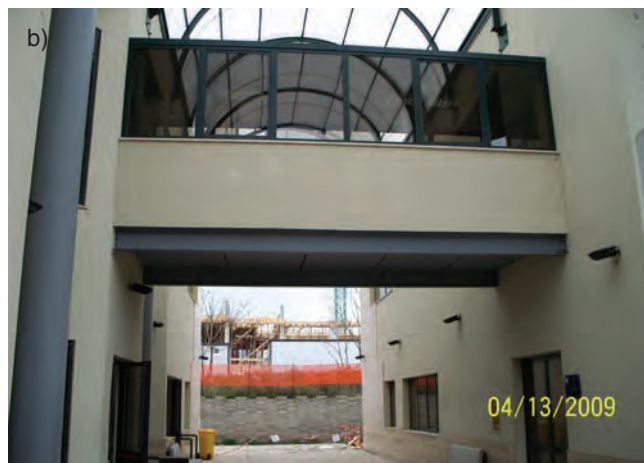
Fig. 19. The differential horizontal motion between neighboring structures is usually expressed by some damage in the bridging structure and the connecting parts; a) in the ceramic factory in Sant' Agostino and b) in the University of L'Aquila after the 2009 earthquake. At both cases not any sign of differential horizontal motion was noticed.

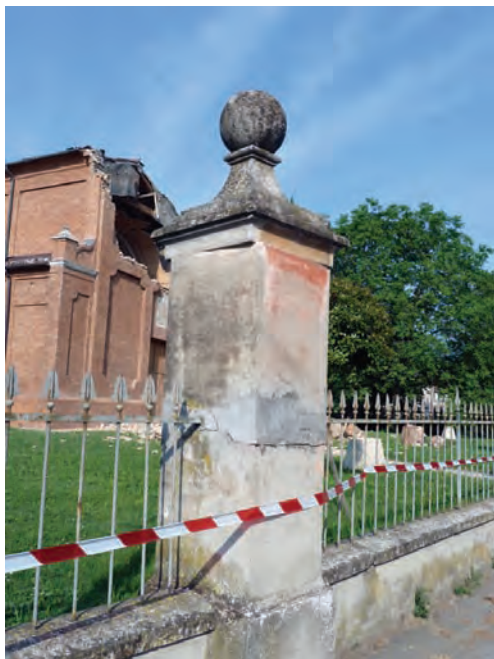
Fig. 22. The sculpture has not any horizontal translation; only torsion due to unsymmetrical friction at its base. Its dimensions are quite small to attribute this motion to any peculiarity of the horizontal ground motion. La scultura non mostra segni di traslazione orizzontale, ma esclusivamente torsione a causa di un attrito non simmetrico alla base. Le sue dimensioni sono troppo piccole per poter attribuire questo tipo di spostamento a qualche peculiarità del moto orizzontale del terreno.

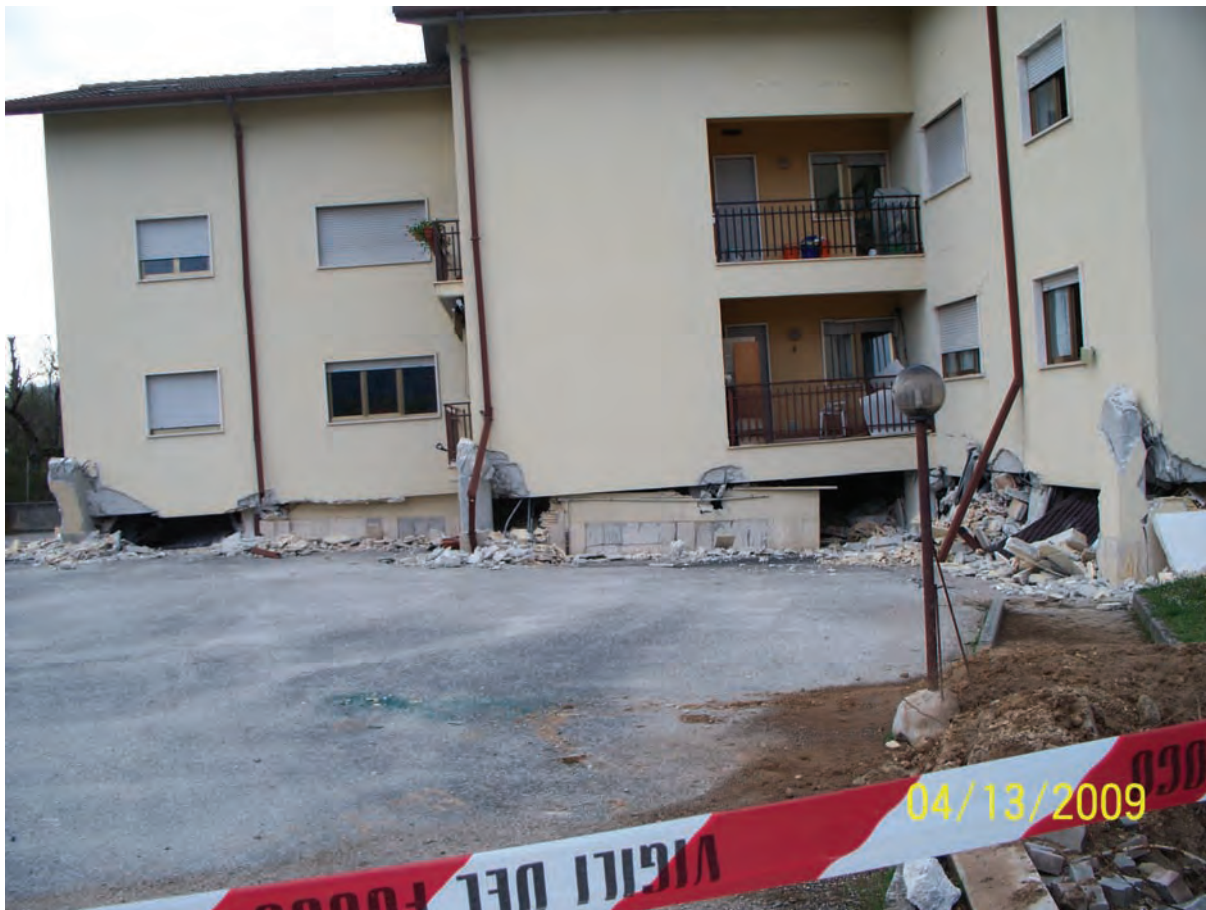
Fig. 24. During the L'Aquila, 2009 earthquake all perimetric columns at the base of the structure were displaced outwards, the building sat down almost vertically, while most of the glass panels remained unbroken, and almost no other damage was optically observed from the outside.

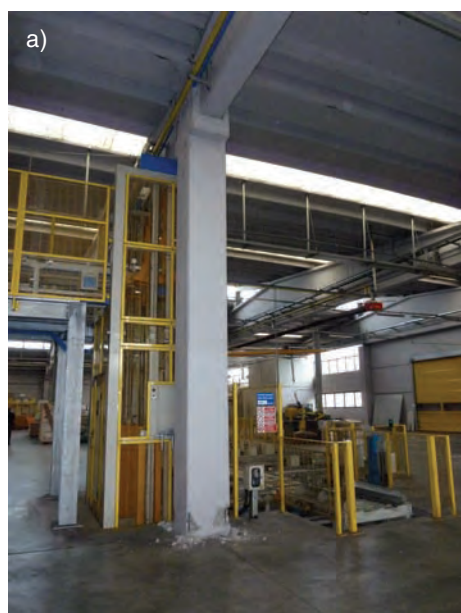
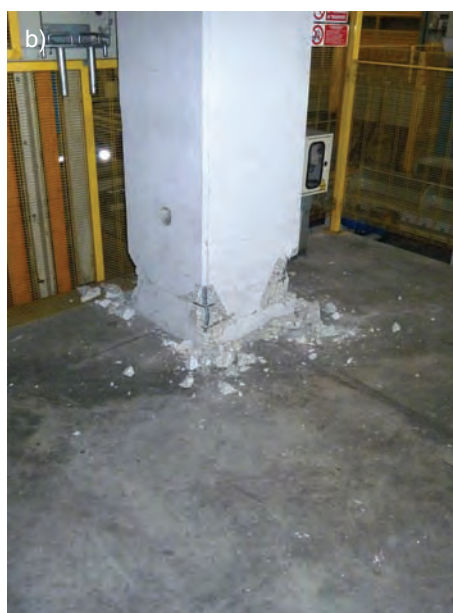
Fig. 25. a) A reinforced concrete structure, in Sant' Agostino ceramic factory, the only recorded damage was around the base of almost all its internal columns; b) There is no shortening of the column at the point of impact. Apparently the damage was caused by tension. Due to this tension the intensity of the impact is augmented, because of the stored energy in the reinforcement.

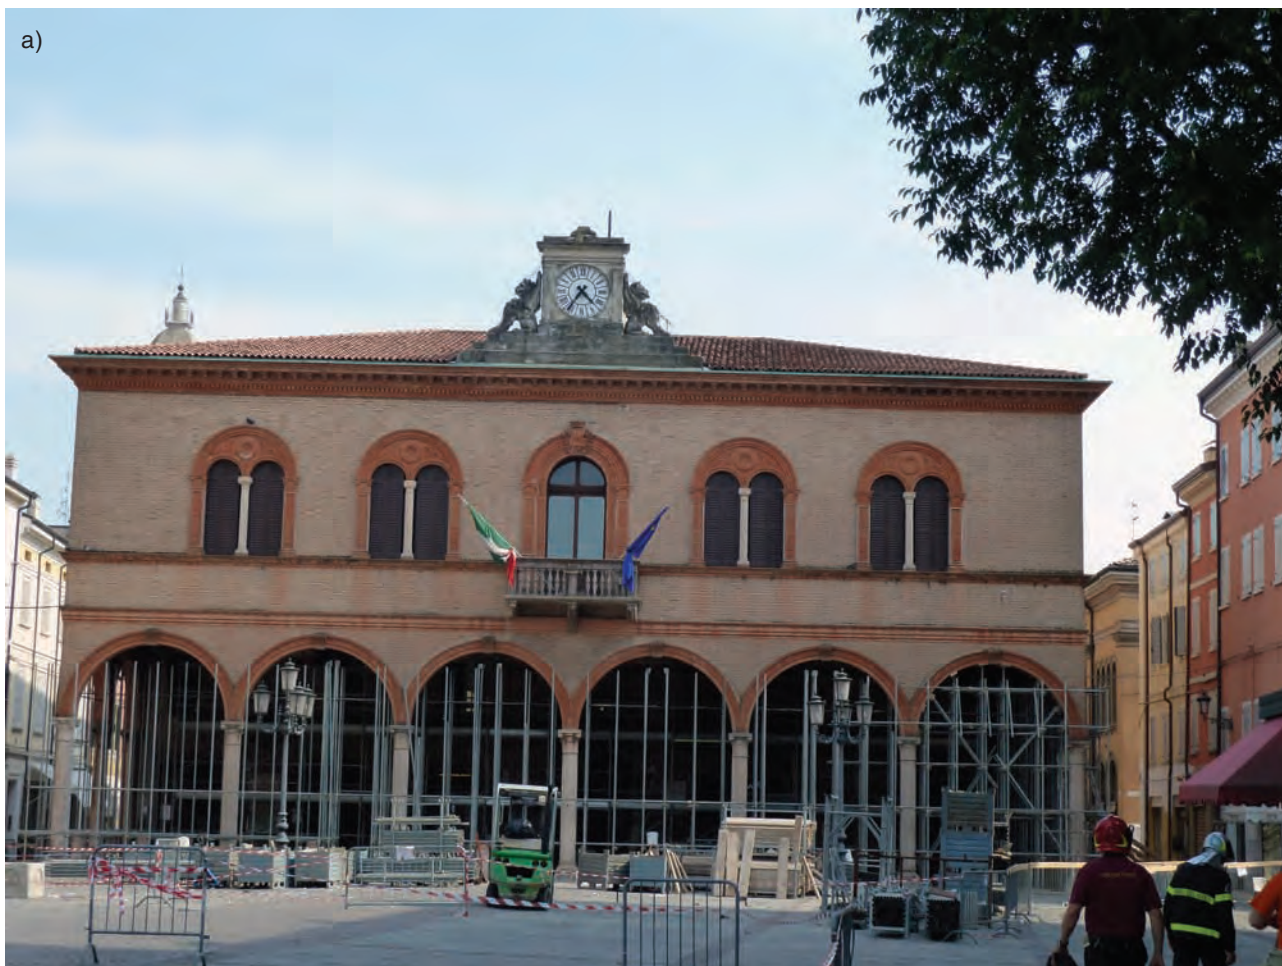
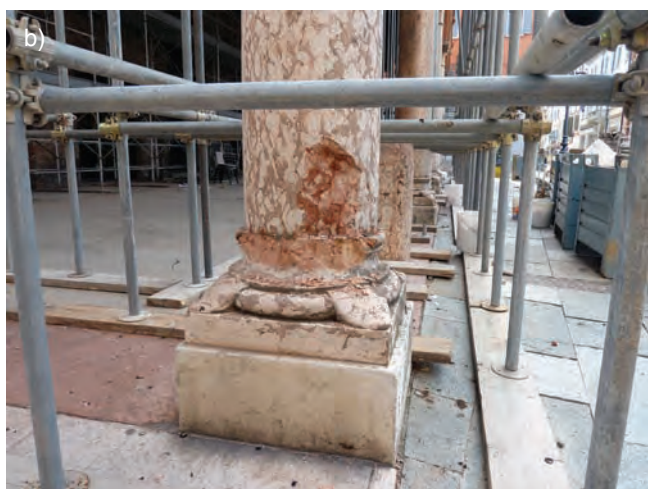
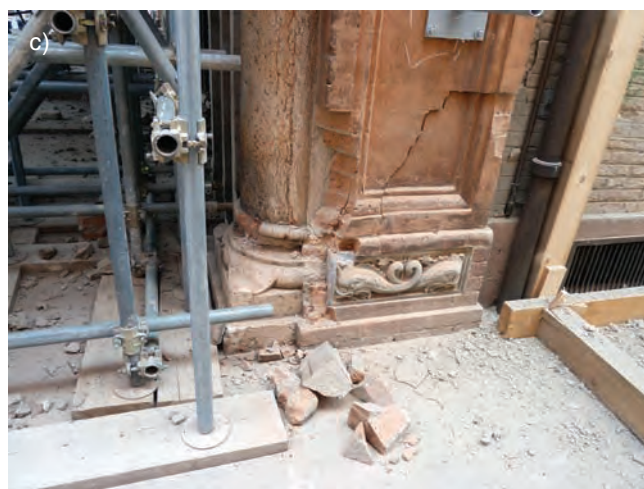
Fig. 26. The Mirandola Town hall; a) no major damage is noted by a rapid optical survey from the exterior, except the damage shown in b) and c) at the bottom of the masonry columns due to impact.

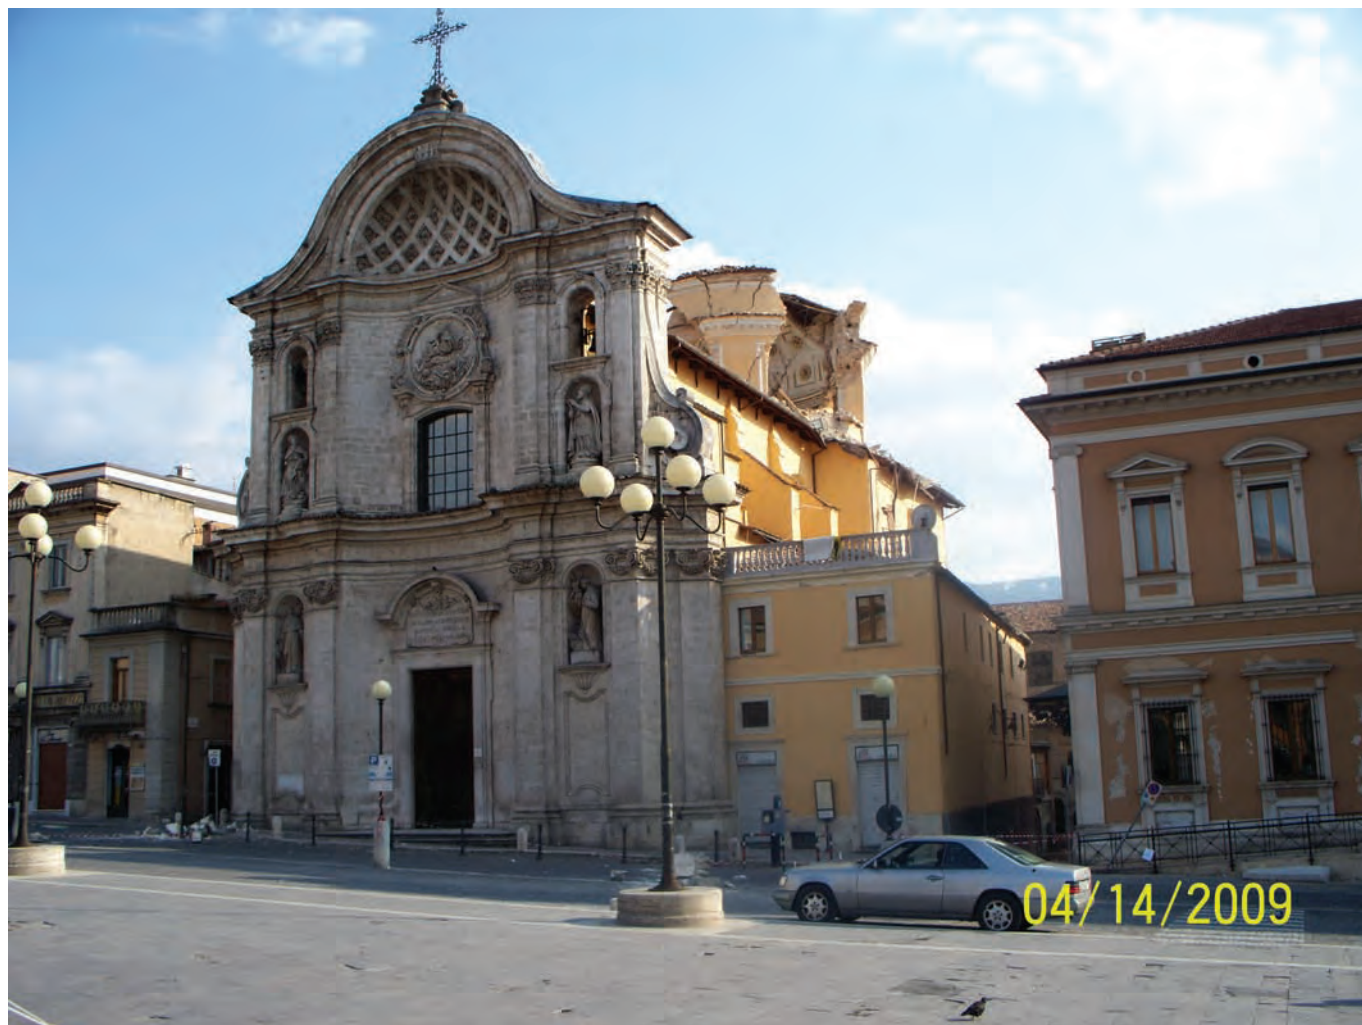
Fig. 27. Vertical collapse within the plan of the ground floor of the dome of Duomo church in L'Aquila, after the 2009 earthquake. There is not any other noticeable damage. Glass window panels are intact.

An other example is given in Fig. 27 in which the dome collapsed vertically within its plan. This type of damage is a trademark of the presence of a strong vertical earthquake component.

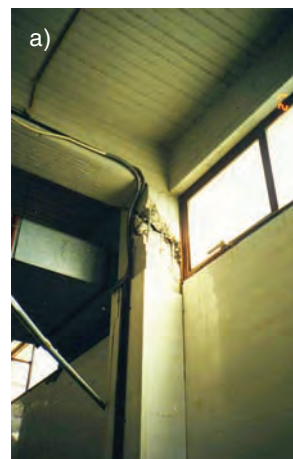
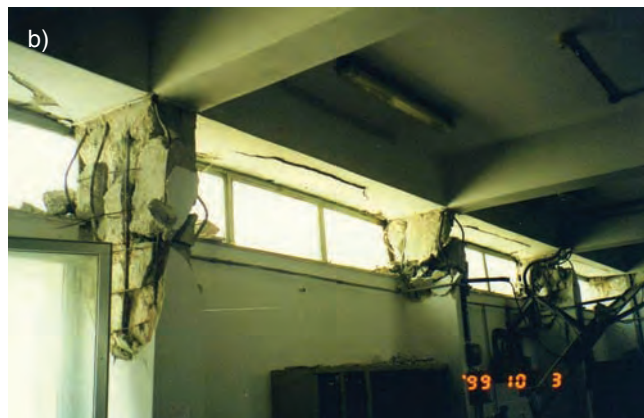
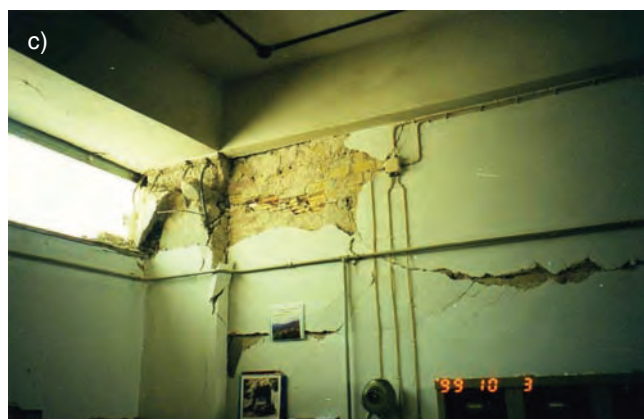
Fig. 29. "Short column", under a vertically propagated body wave action. The braking plane is perpendicular to the plane of the concrete wall and the respective beam. The adjacent window glass panel is unbroken. Not any significant residual vertical shortening is noticed. In c) the presence of a masonry wall perpendicular to the plane of the concrete wall did not prevent the break of the "short column".

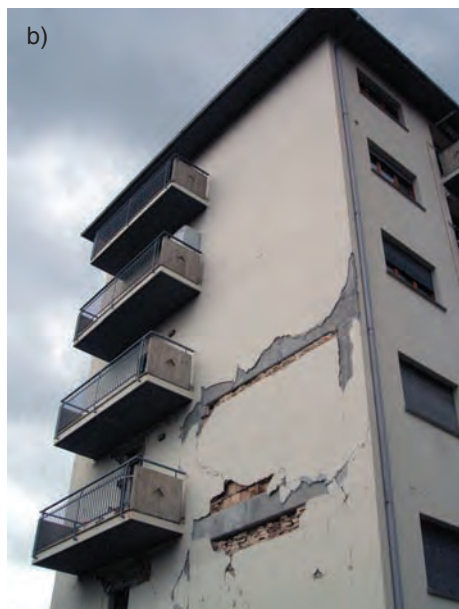
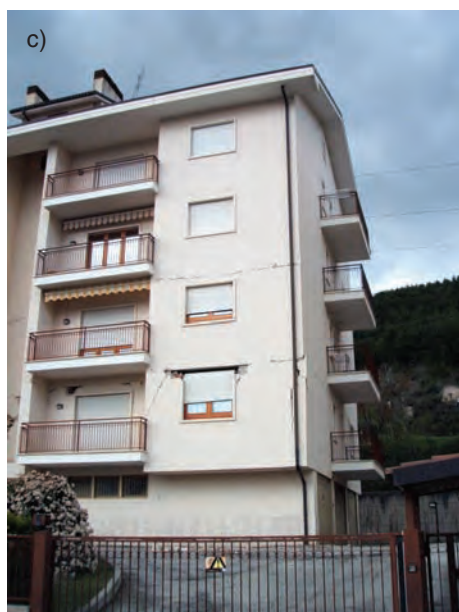
Fig. 30. a) Additional vibrational effects on floors and roofs from the vertical earthquake component. Usually in most cases, the walls above the floor or roof level are toppling inside the building. This means that the fall is due to upwards motion of the supports (perimetric walls); b) and c) Damages observed in Pettino (L'Aquila) after the 2009 Earthquake  
a) Effetti delle vibrazioni sui solai e le coperture, a causa della componente verticale del sisma. Nella maggior parte dei casi, i muri al di sopra del livello del solaio o del tetto ricadono all'interno del perimetro dell'edificio. Ciò significa che la caduta è dovuta al moto verso l'alto degli appoggi (muri perimetrali); b) e c) danni osservati a Pettino (L'Aquila) dopo il terremoto del 2009.

This fact explains the causes of horizontal cracks observed in many buildings (e.g. in L'Aquila after the 2009 earthquake as shown in Figs 30b and c), at the lower floor levels, eventually at the interface between r/c beams and masonry infills. A probable explanation is based on: a) the dynamic difference between a r/c beam (and as we can see of a considerable length) and a brick wall and b) the impact phenomenon on this type of structures, seems to be stronger at their lower floors. At the building of Fig. 30c, the damaged façade

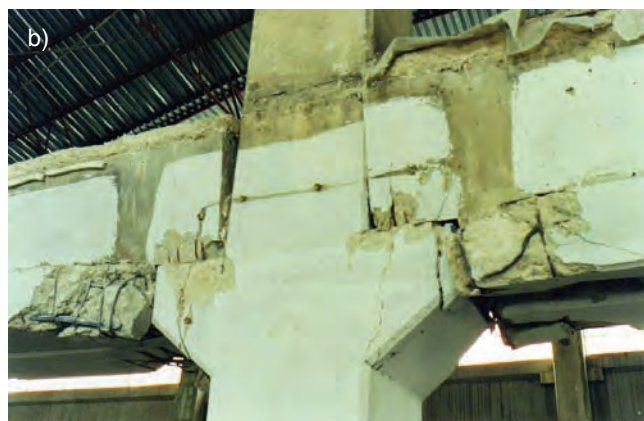
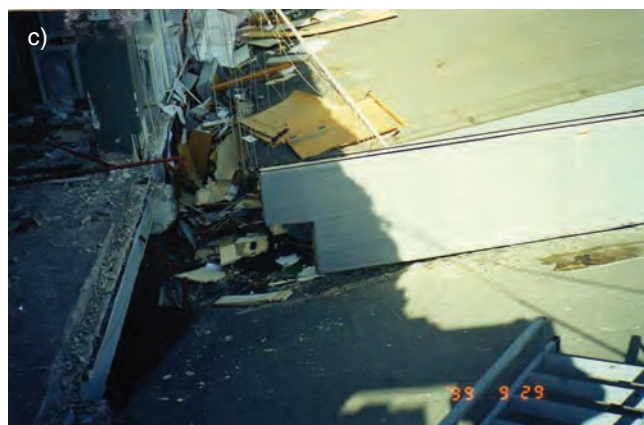
Fig. 31. a) Due to the vertical seismic component, the beam is jumping up and down on its supports if it is not sufficiently anchored; b) the corbel or the beam, or both are broken. In this case a vertical bolt is provided but it was too short and the beam jumped over; c) if there is a horizontal motion too, the results are worsened.

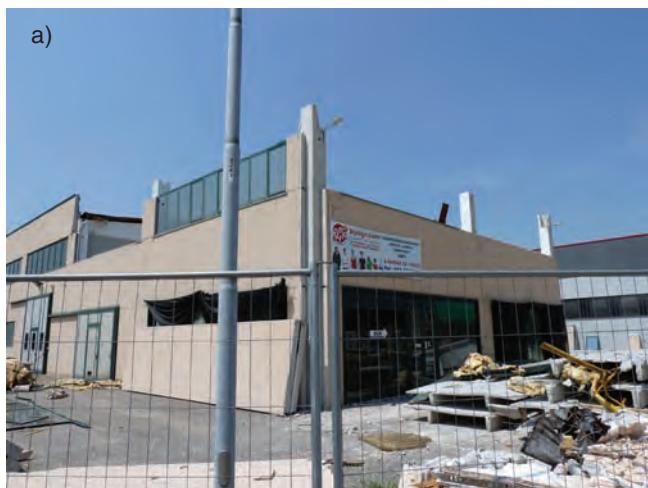
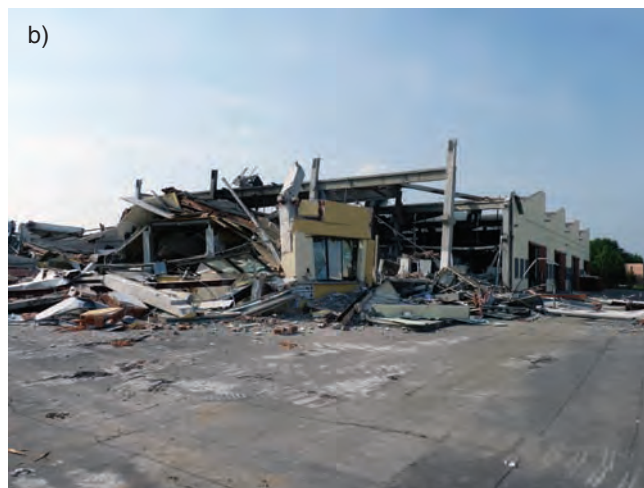
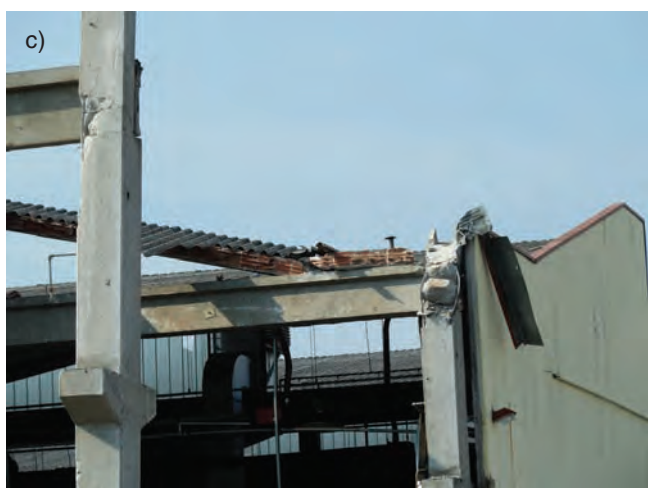
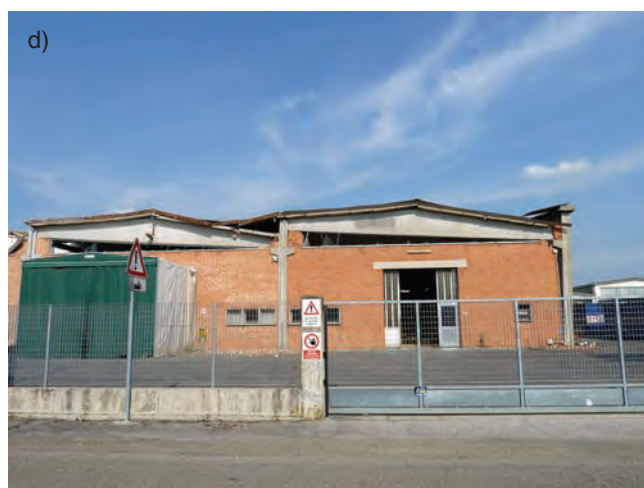
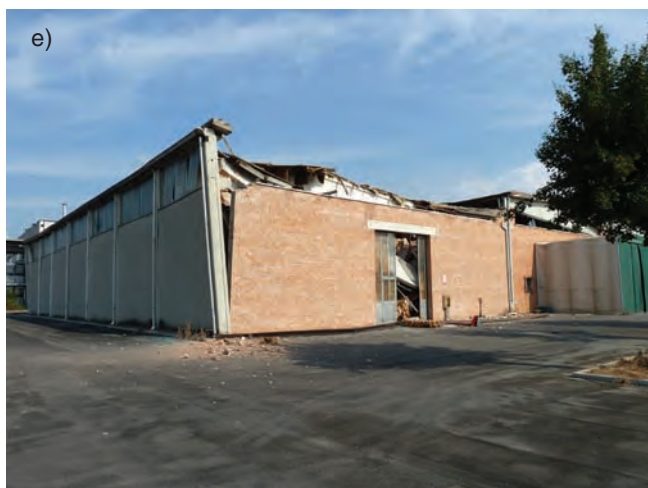
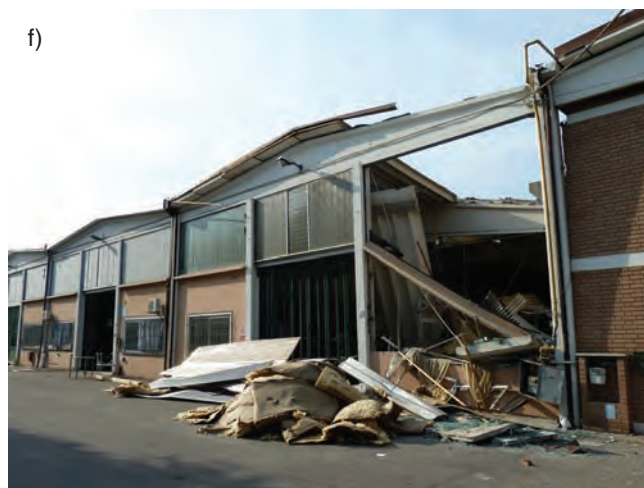
Fig. 32 a to f *Simply supported prefabricated beams for the roofing systems and without any reliable anchoring were subjected to a combination of a very strong-impact-type-vertical component with a strong horizontal one. Those images of destruction are typical around the epicentral region.*  
 Travi di copertura prefabbricate in semplice appoggio, prive di collegamenti affidabili, soggette alla combinazione di una forte componente sismica verticale e di una forte componente sismica orizzontale. Immagini di danni di questo tipo sono caratteristiche delle zone epicentrali del terremoto.

The lack of those provisions in the supports might be the basic reason for the numerous damages and collapses of industrial buildings' roofs made with prefabricated beams as it is shown in Figs. 32a to f. On the other hand, if any kind of beam to column joint was provided the response of the vertical element would be ameliorated. After that, we may conclude that structures, as the prefabricated ones, that are going to be applied in great numbers, must be designed for a higher degree of importance, than the one presently considered in Seismic Design Codes.

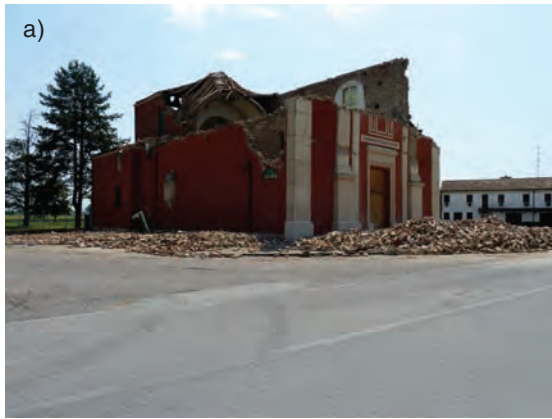
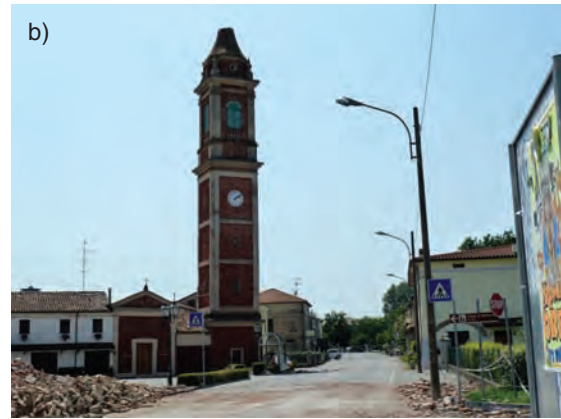
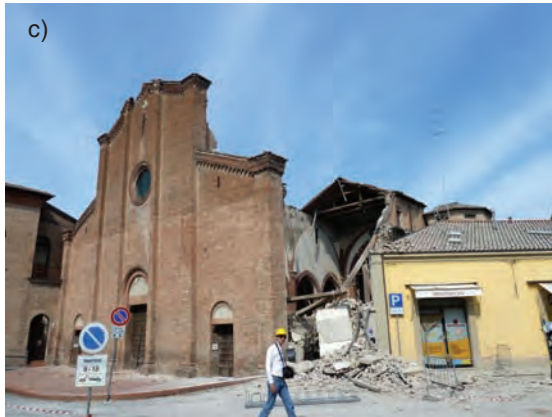
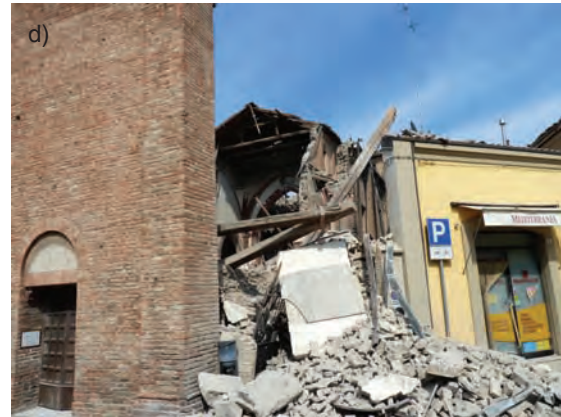
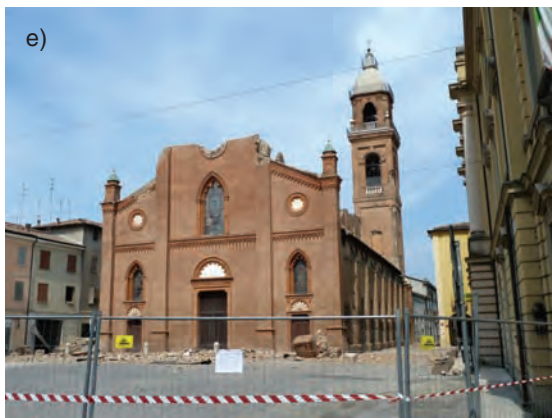
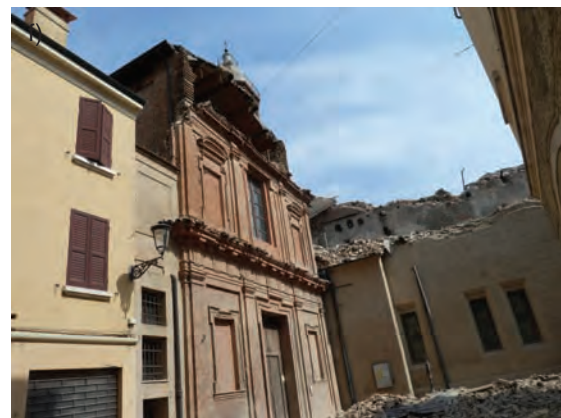
Fig. 33. The incurred damage of churches follows almost an identical pattern. The bell towers survived with only minor damage along the height. In most cases the top of the spire was damaged; a), b) church of San Marino at Buonacompra; c), d) church of San Francesco at Mirandola, very heavy damage. The bell tower collapsed after the second event; e) Santa Maria Maggiore, Cathedral of Mirandola; f) a view from the north towards S-E; g), h), two damaged churches in Mirandola.

A typical response of the bell towers is shown in Figs. 33b, e and h, in which the top of the spire was damaged. Some minor damage is observed on the rest of the body of the bell tower along the height and

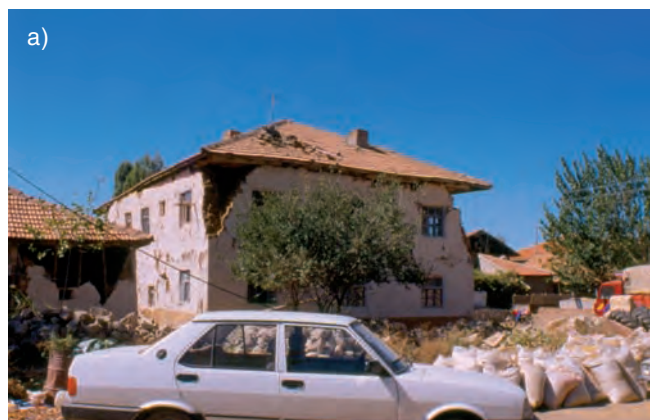
Fig. 36. A selection of representative damage incurred in masonry buildings as well as undamaged buildings. Each one of those deserves a special in depth investigation.

In Figs. 36a to f a representative set of damaged and undamaged masonry structures, each one deserving a special and in depth study, is presented. For example, case b) shows a set of adjacent buildings that were almost not moved, since the joint between them and the window glass panels are intact. Also, absolutely intact are the cases d) and e). In case e)

a lot of modifications have been carried out as it is externally observed.

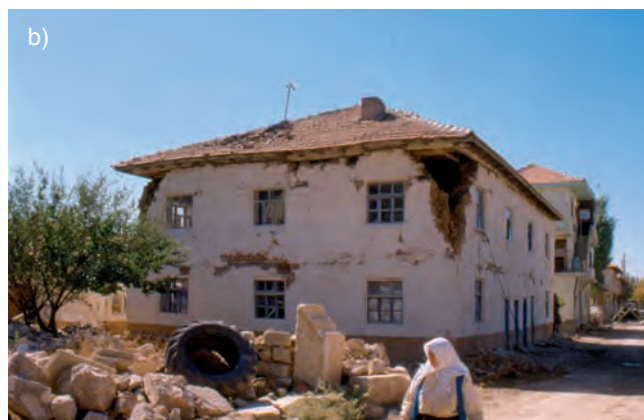
Figs. 35 a, b The damage to symmetrical masonry structures are symmetrical around the vertical vector. The well known diagonal cracks are not developed. The horizontal cracks at roof and first storey levels are due to vertical vibration of the roof and floor respectively. Typical is the detachment of all four top corners around the building. Dinar, Turkey, 1995 earthquake, /14/.
