The October 23 ($M_w = 7.2$) and November 9 ($M_w = 5.7$), 2011 Van, Turkey earthquakes. A geoscientific and engineering report

Panayotis Carydis*, Efthymis Lekkas**, Christos Papaioannou***, Andreas Tsokos****, John Delakouridis*****

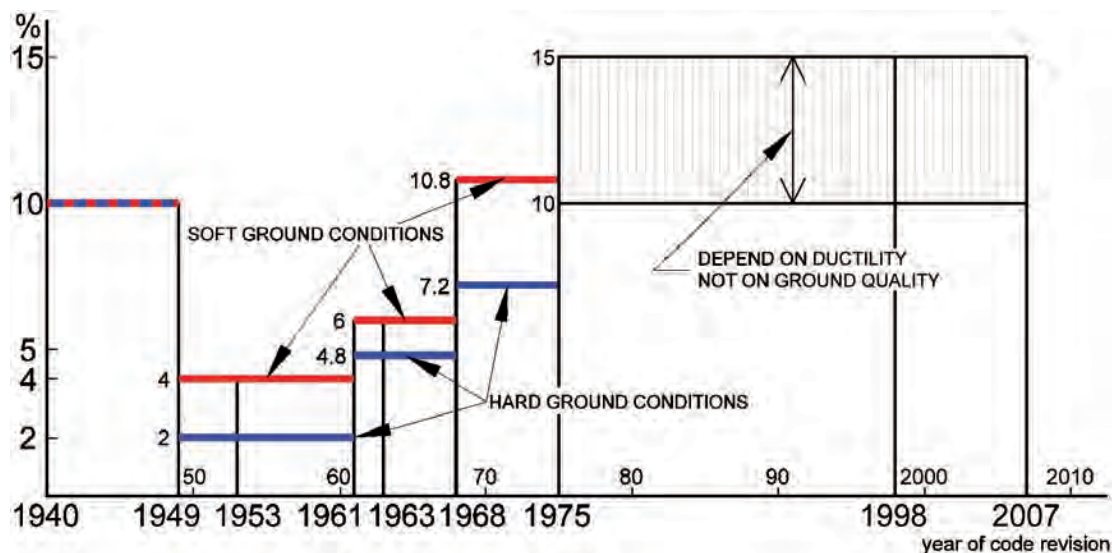
Fig. 15. Evolution of base shear design coefficients for a 5-storey hotel building in the city of Van (in the highest seismic zone).

In Fig. 15 the base shear design coefficients for the hypothetical hotel building in the city of Van are plotted against time, with all calculations referring to the allowable stresses method.

Based on the diagram of Fig. 15, it is obvious that during the period 1949-1975 quite low seismic coefficients were used. It must be emphasized, also, that those low values of seismic coefficients correspond to the highest seismic zones in which the city of Van belonged before the last two revisions of the seismic code. The abrupt and excessive reduction of the seismic coefficients from 0.10 that were used during the decade 1940-1949, to something around 0.03, as a mean value during the next decade 1950-1960, should also be noted. It must be mentioned here that seismic coefficient values below 0.05 with a parallel increase of the allowable stresses by 50% do not consist any noteworthy earthquake structural resistance, especially in regions of the highest seismic hazard zone in the country. Namely, those buildings can hardly safely withstand an effective peak ground acceleration of more than 0.05 g and under the best structural qualifications 0.15 g. These thresholds are further reduced in the case of buildings with a soft ground storey as this is the case of buildings at the city shopping centers, with ground floors functioning as shops possessing larger show rooms, openings and shop windows. As far as the vertical seismic component is concerned, no provision is
